# Site Visits Report (September 2021)

E&S SITE VISITS OF QUARRIES, MOBILIZATION CAMPS,  
CONCRETE & PRECAST PRODUCTION AREAS

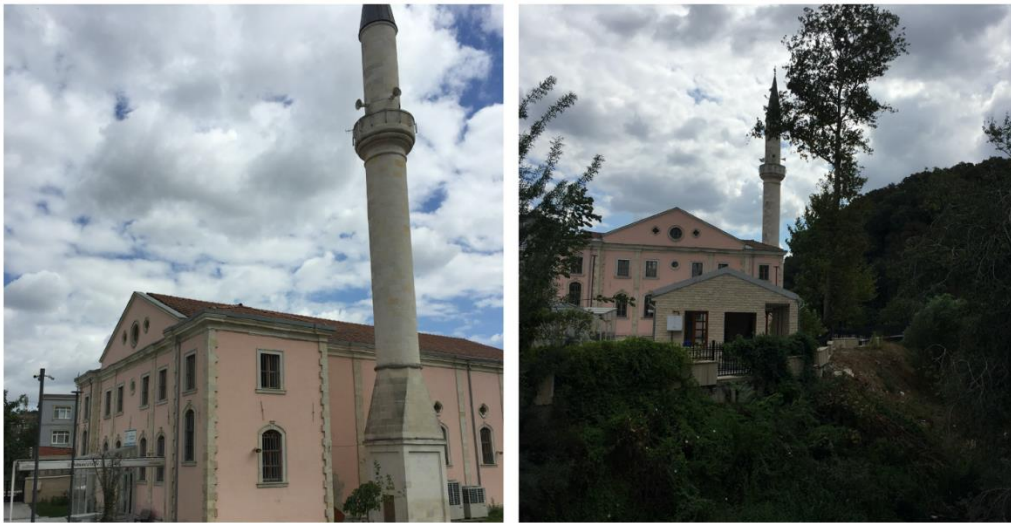
**Figure 1-3 Photos of Boğazköy Mosque**

Boğazköy Mosque is situated on Milli Egemenlik Street, near Alibey Stream. It resembles a historic building converted from a church into a mosque. It is approximately 200 to 300 meters from the project area.

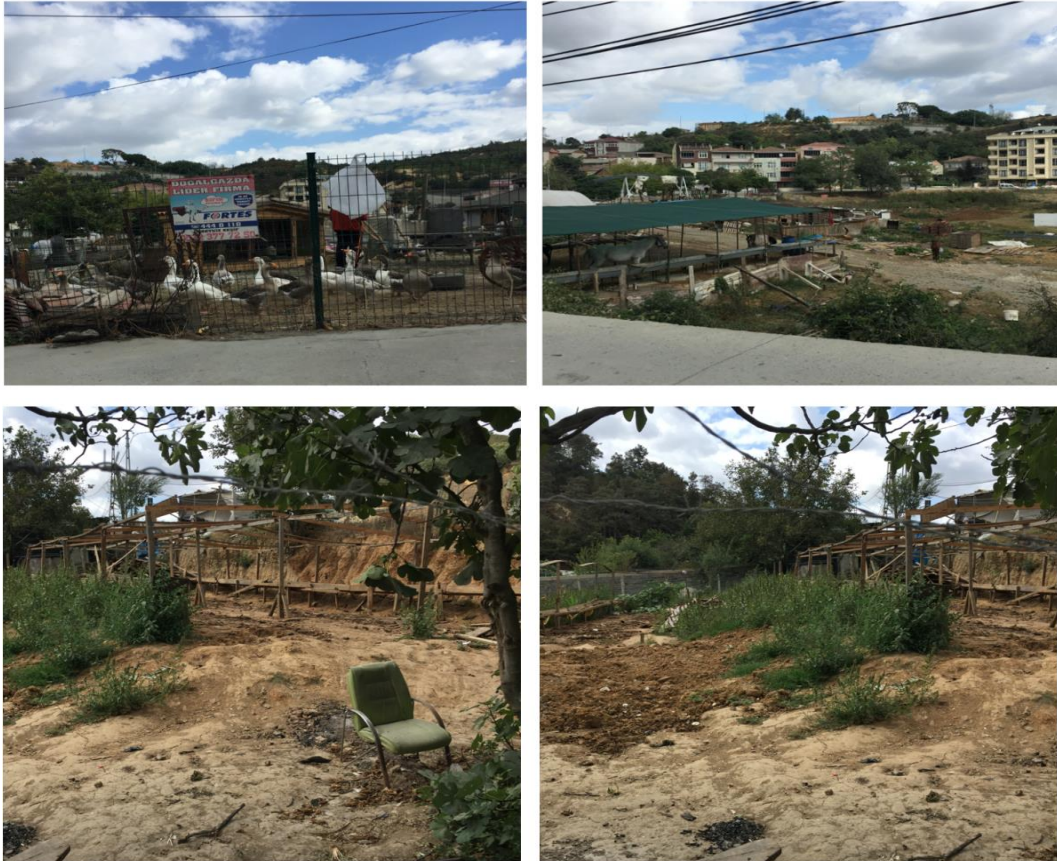
Figure 1-7 Photos Animal Shelters

During the trip, it was observed that livestock activities are not carried out on a large scale in Bogazköy around the quarry. There are around 4 barns on Emre Street, which are currently empty. These barns are being used for the sales of animals for religious festivals. There is also a stable and poultry house on Milli Egemenlik Street. It is understood from the advertisements on the barns that the animals here are for sale. These barns are not a building-shaped structure, but a makeshift one. With the exception of the animals in this hen house and stable, no animals were found in the area.

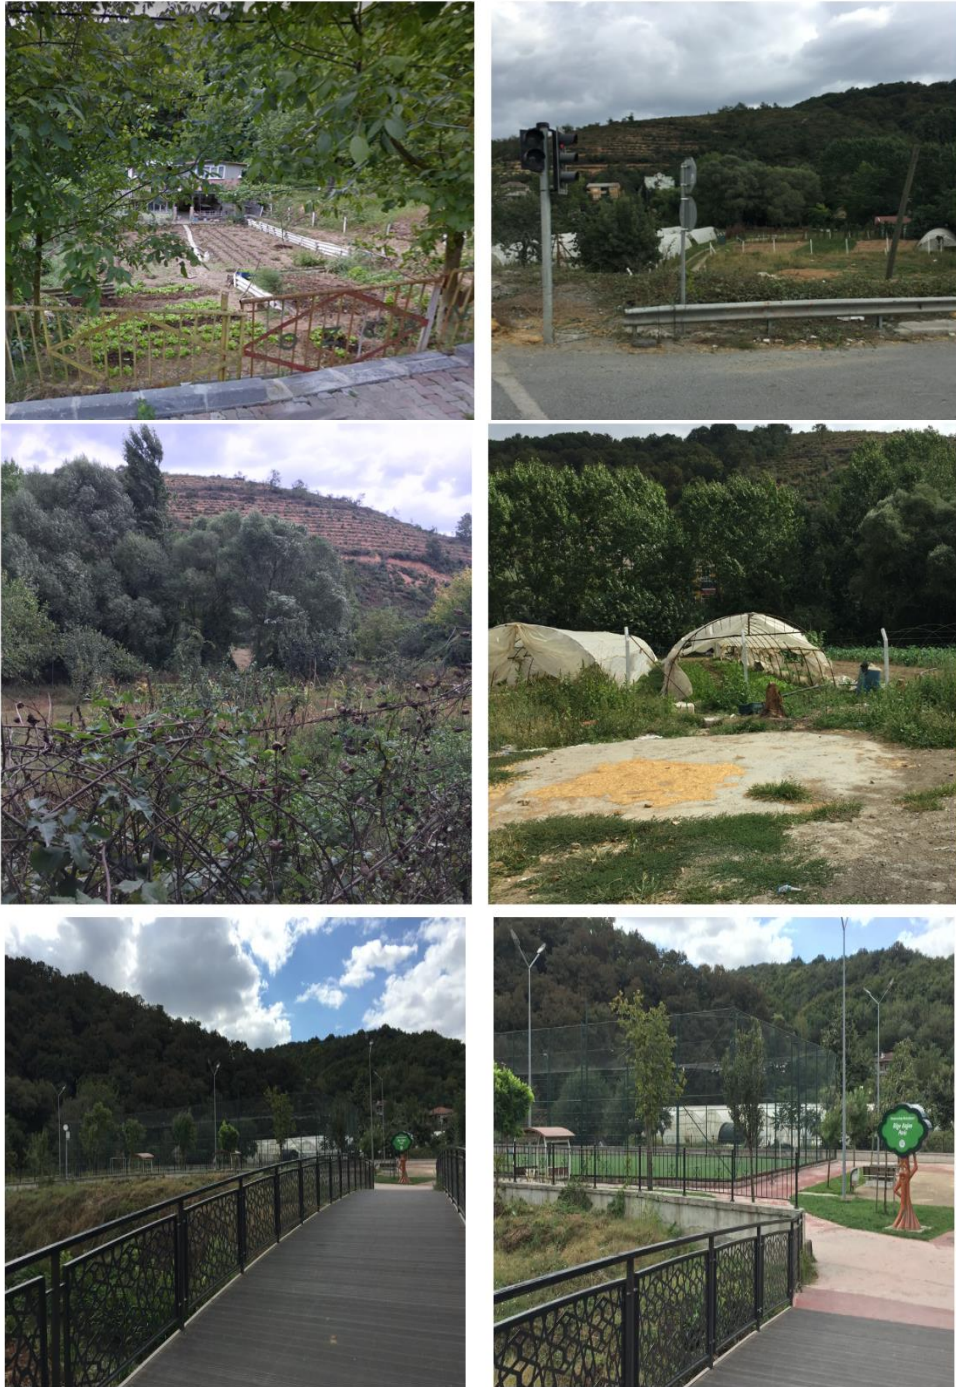
**Figure 1-8 Photos of Agricultural Areas in Boğazköy**

Greenhouse cultivation is located in two distinct zones. The first area lies between Milli Egemenlik Street and Ziyali Street (north of the quarry), behind Boğazköy Mosque and north-east of the area. The greenhouse cultivation was carried out in the areas to the right of the junction to the northeast of the field, Emre Street. There are 8 greenhouses in the area. Horticulture is also practiced at Emre Sokak. Sunflowers have been identified as being planted in small gardens. There are also places to be used for the sales of sacrificial animals can be found on Emre Street.

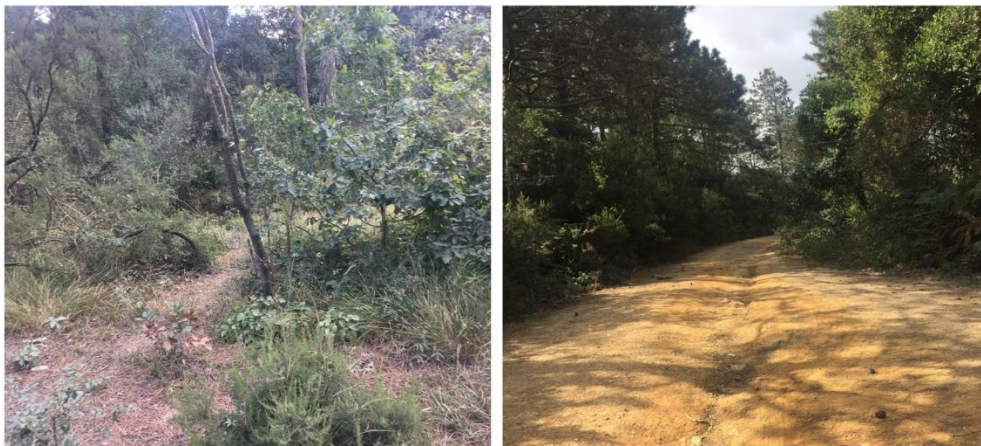
**Figure 1-14 Photos from additional operation plant**

Operation plant is within the borders of Fethi Pasha Grove. No residential, commercial or social areas were found around this area.

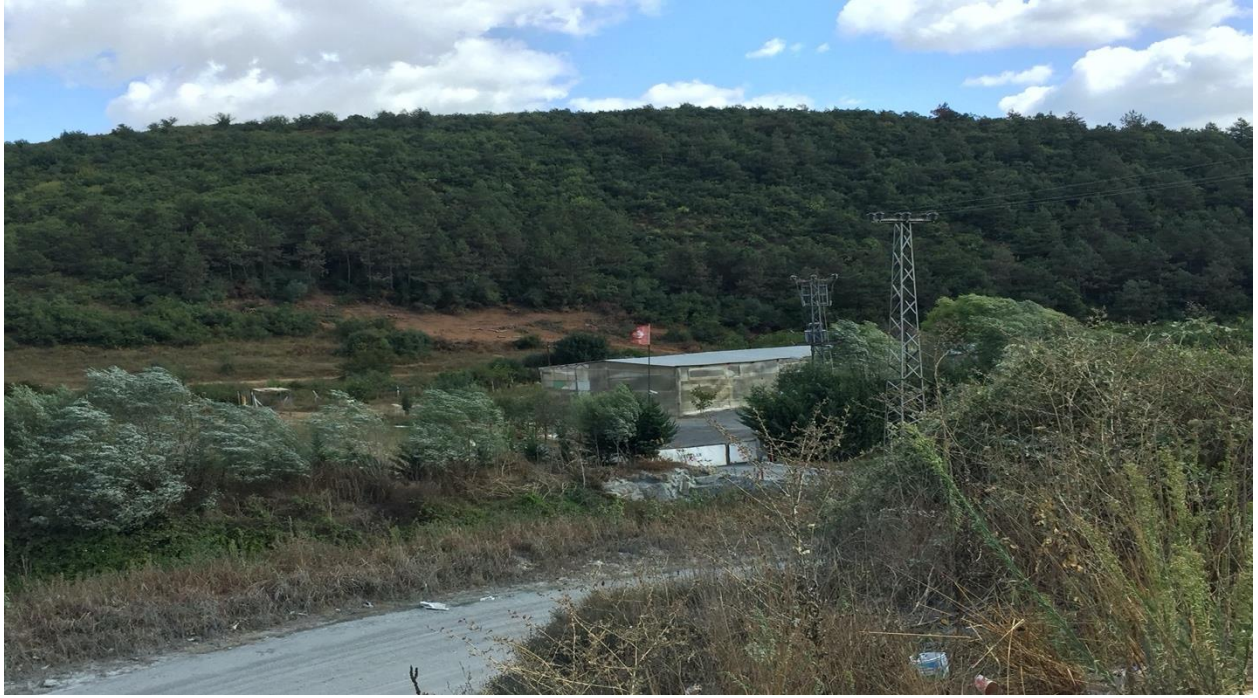
**Figure 2-2 Photo of greenhouse nearby HAKTAŞ Qaurry**

There is a greenhouse at the end of the watermelon fields at a distance of 200 m from the quarry in the northeast of the area.

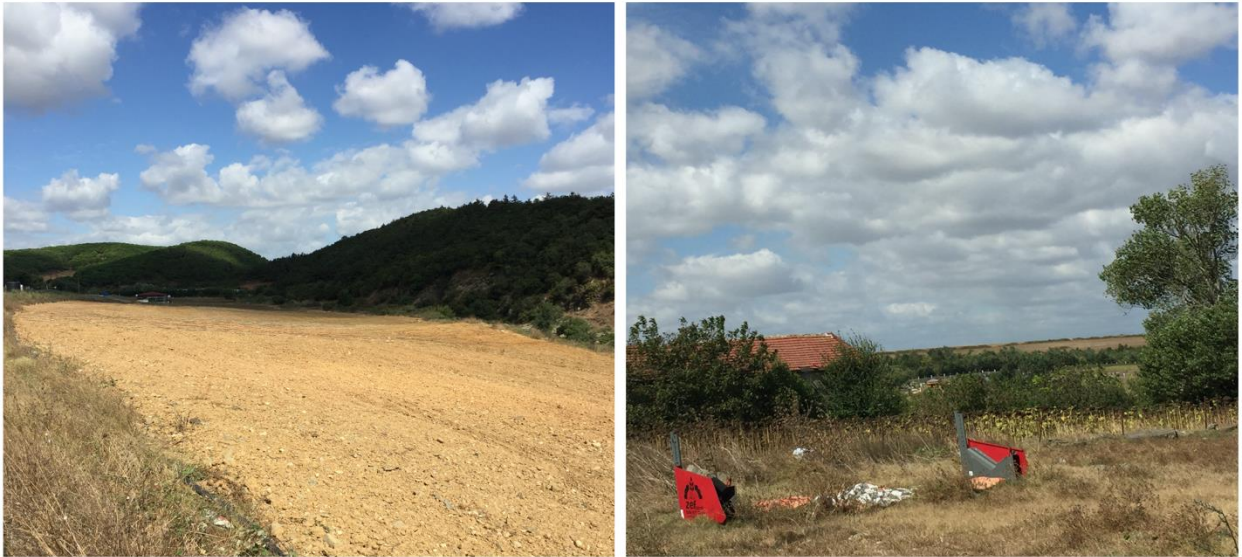
**Figure 2-3 Sunflower fields in Hacımaşlı**

Animal husbandry is common in the village of Hacımaşlı. Based on the observations, there are many cattle barns in the village in close proximity. There are 4 big barns side by side in the village of Hacımaşlı, about 1.3 km to the west of the area. In addition, the sunflower cultivation is also common.

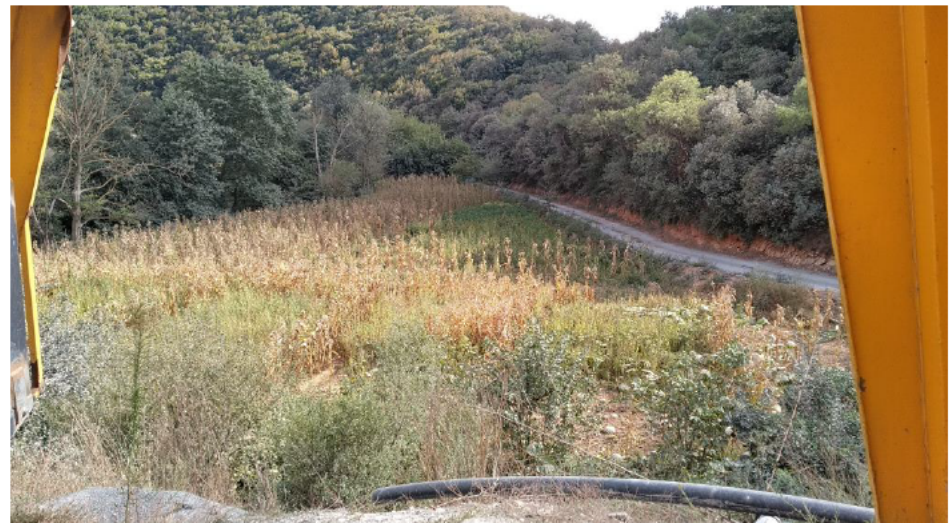
There is a creek within the site boundaries

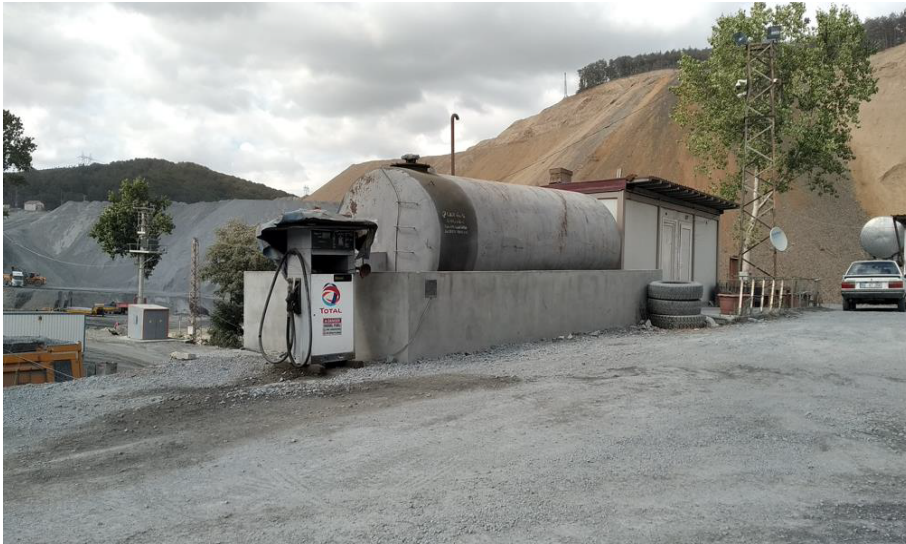
Diesel tank

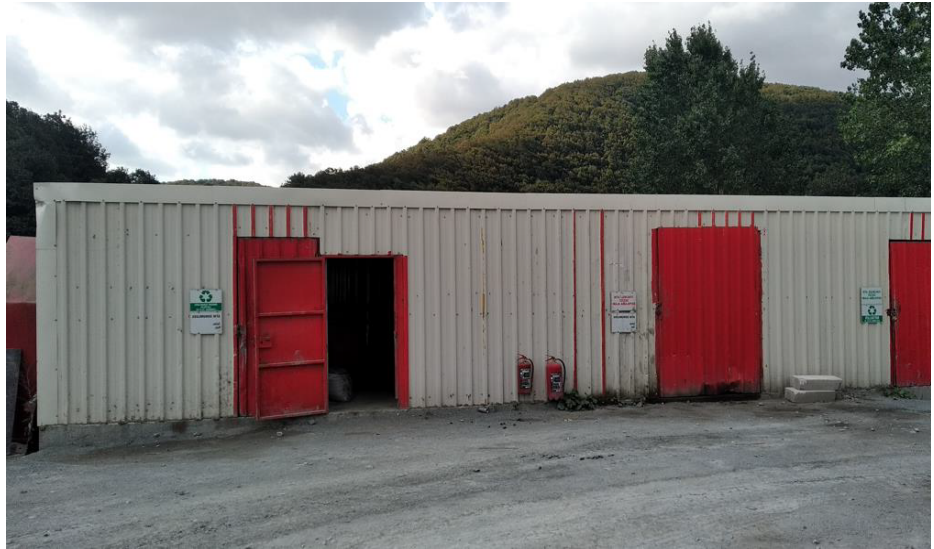
Temporary hazardous waste area

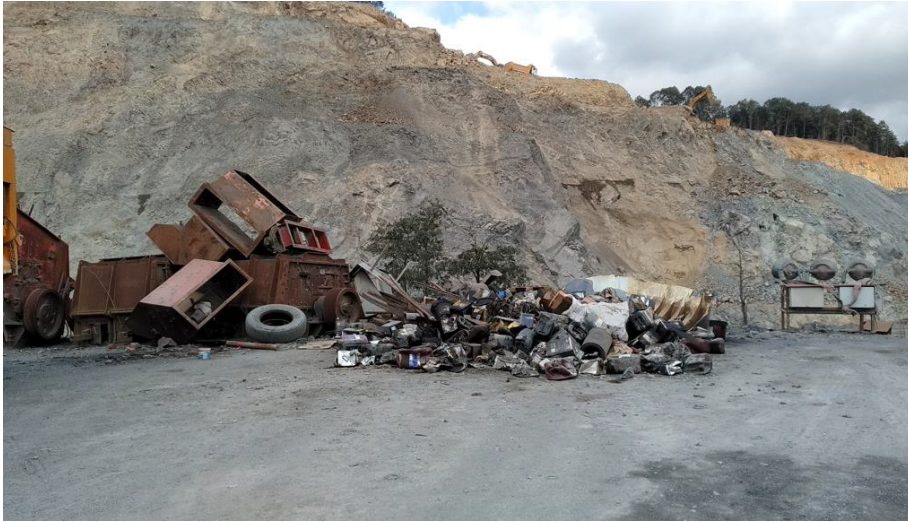
Hazardous wastes and scrap metals on the soil

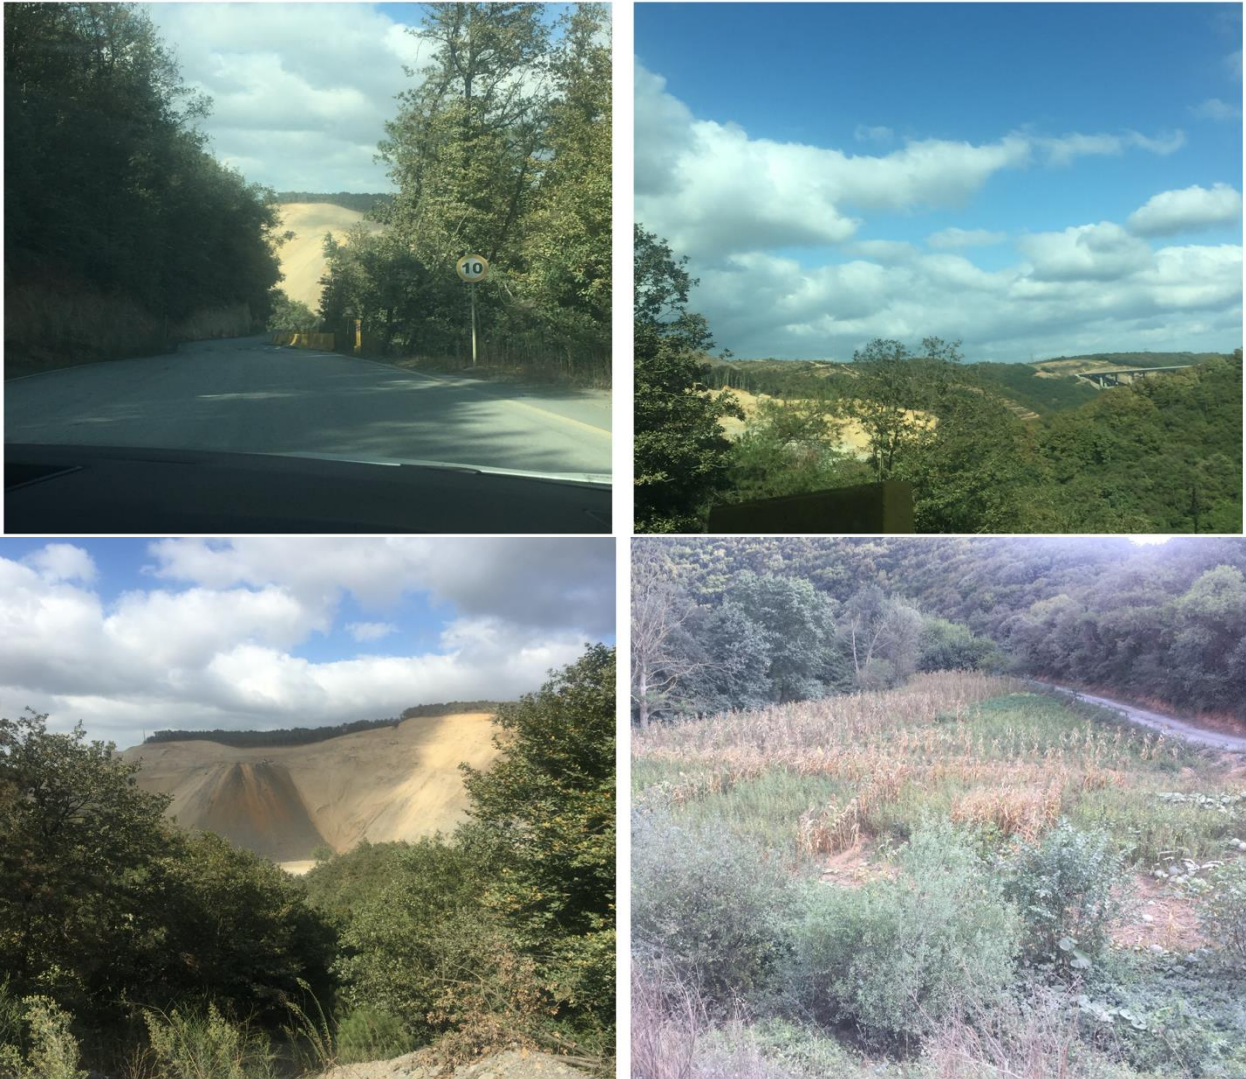
**Figure 3-1 Photos from new operation plant**

No residential, commercial, or social areas were found around this area. It was determined that only a small field in the quarry was cultivated with corn.

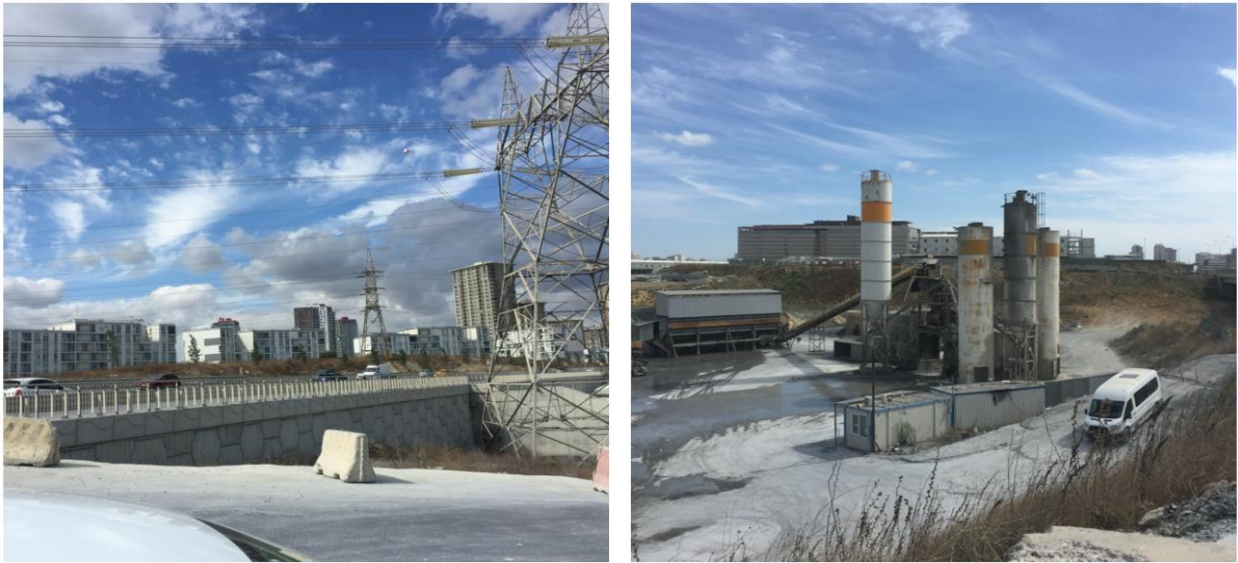
**Figure 4-1 Photos form Olympic Concrete Plant**

There is the city hospital to the south of the Olympic Concrete Plant, the highway at the top, and settlements far to the northwest and west. There are no economic enterprises in the immediate vicinity of the plant. Animal husbandry and agricultural activities were not found.

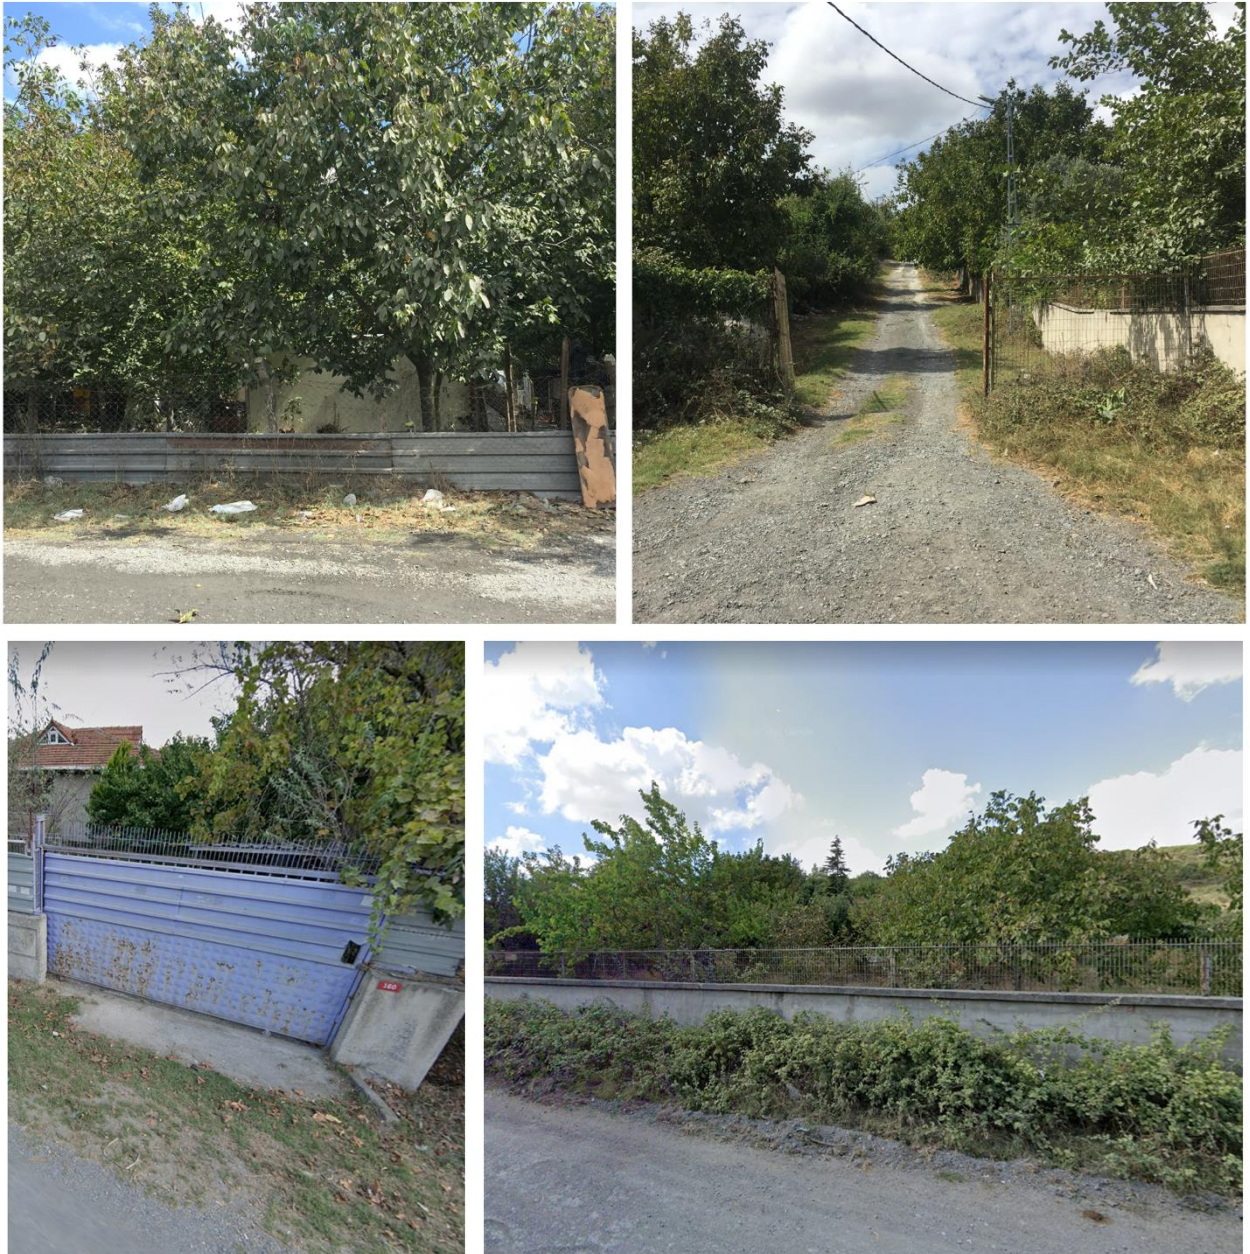
**Figure 7-2 Photo's form Muratdere Street Settlements**

There are houses on the top of the greenhouses. Vegetables are grown in their gardens, possibly for home consumption. The district is an extension of the Şahintepe district. The neighborhood is right above the boundary of the project area.

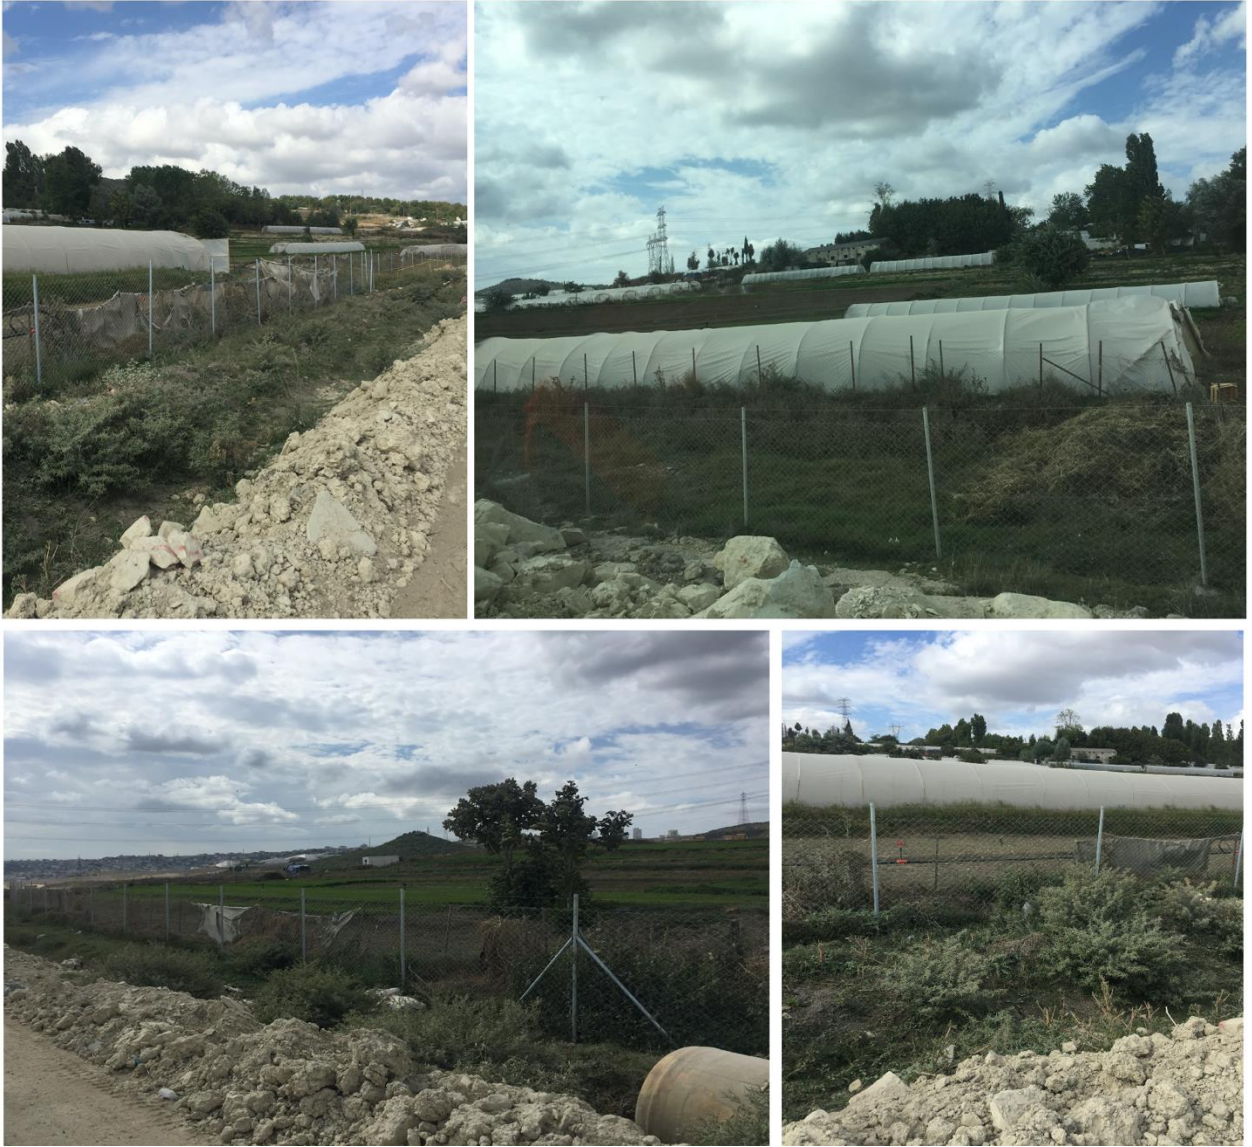
**Figure 7-3 Photo's form Greenhouses**

There are greenhouses at the border on the western shore of the site. In addition, irrigated agriculture is done adjacent to the greenhouses, although it is not very big. There are greenhouses at the border on the western shore of the site. In addition, irrigated agriculture is done adjacent to the greenhouses, although it is not very big. There are a few fields on the top eastern border of the field border. Sunflower and wheat are known to be planted in the fields.

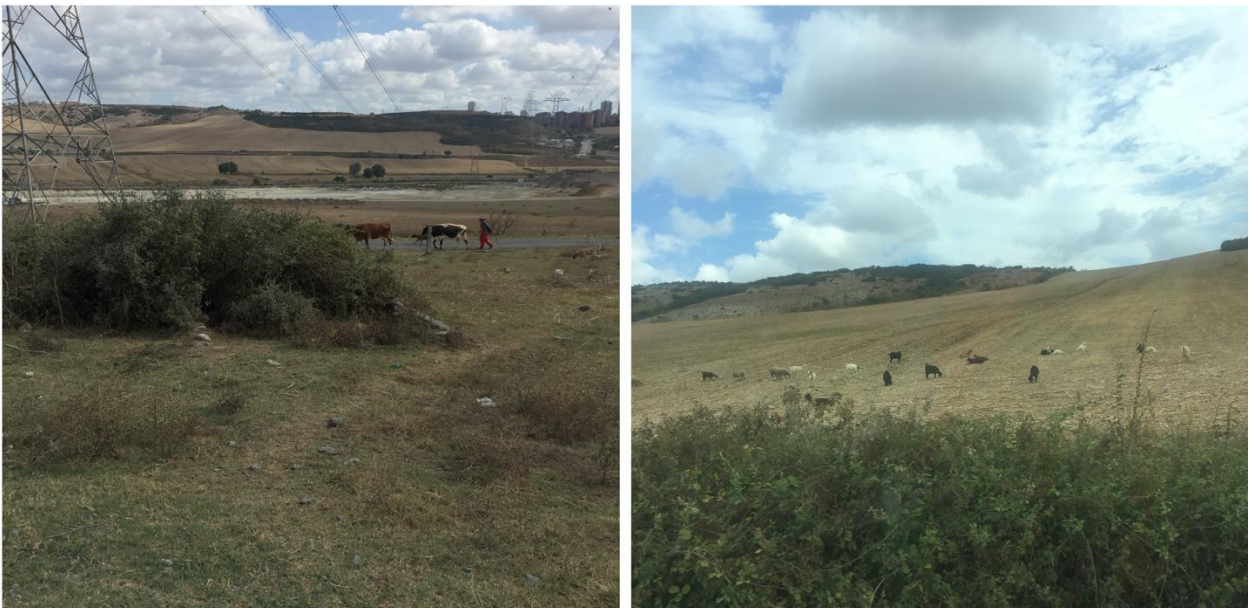
**Figure 7-6 Photos of grazing animals**

Cattle and small ruminants with irregular movements were observed in the project area. Additionally, a small number of cattle grazed by their owners were also seen. Additionally, a small number of cattle grazed by their owners were also seen. There are beehives in two nearby gardens on top of the greenhouses. The number of hives could not be picked up accurately. The hive gardens are located about 0.1-0.2 km from the field limit of the power plant/production site.

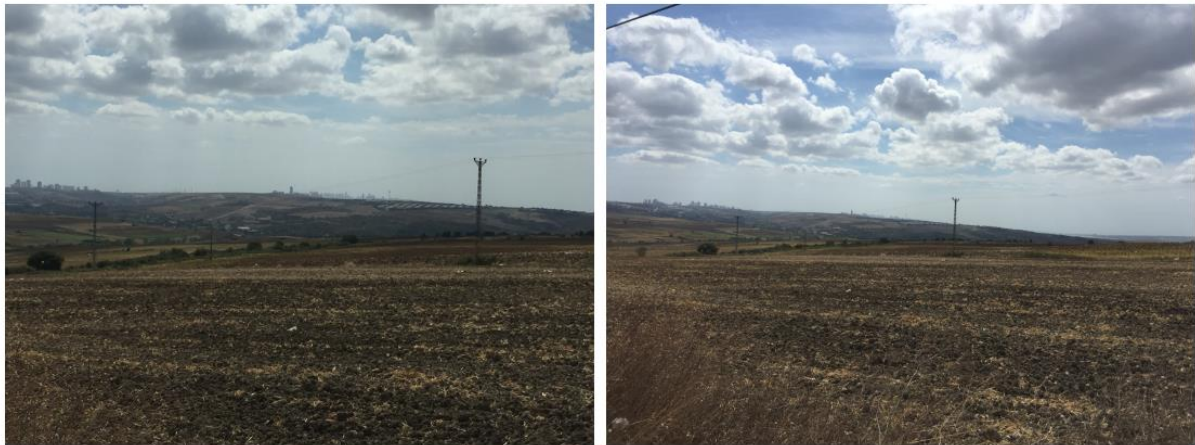
**Figure 8-1 Photos form NAKKAŞ Concrete Plant Area**

No settlement was found in the area where NAKKAŞ Concrete Plant is located. There are companies that have logistics centers in the region. As well, there is a prefabricated production center. Besides the logistics centers, the cultivated agricultural fields are located in the region.
