Central Térmica de Temane Project - Aquatic Biodiversity Report

Moz Power Invest, S.A. and Sasol New Energy Holdings (Pty) Ltd

18103533-320976-10

April 2019

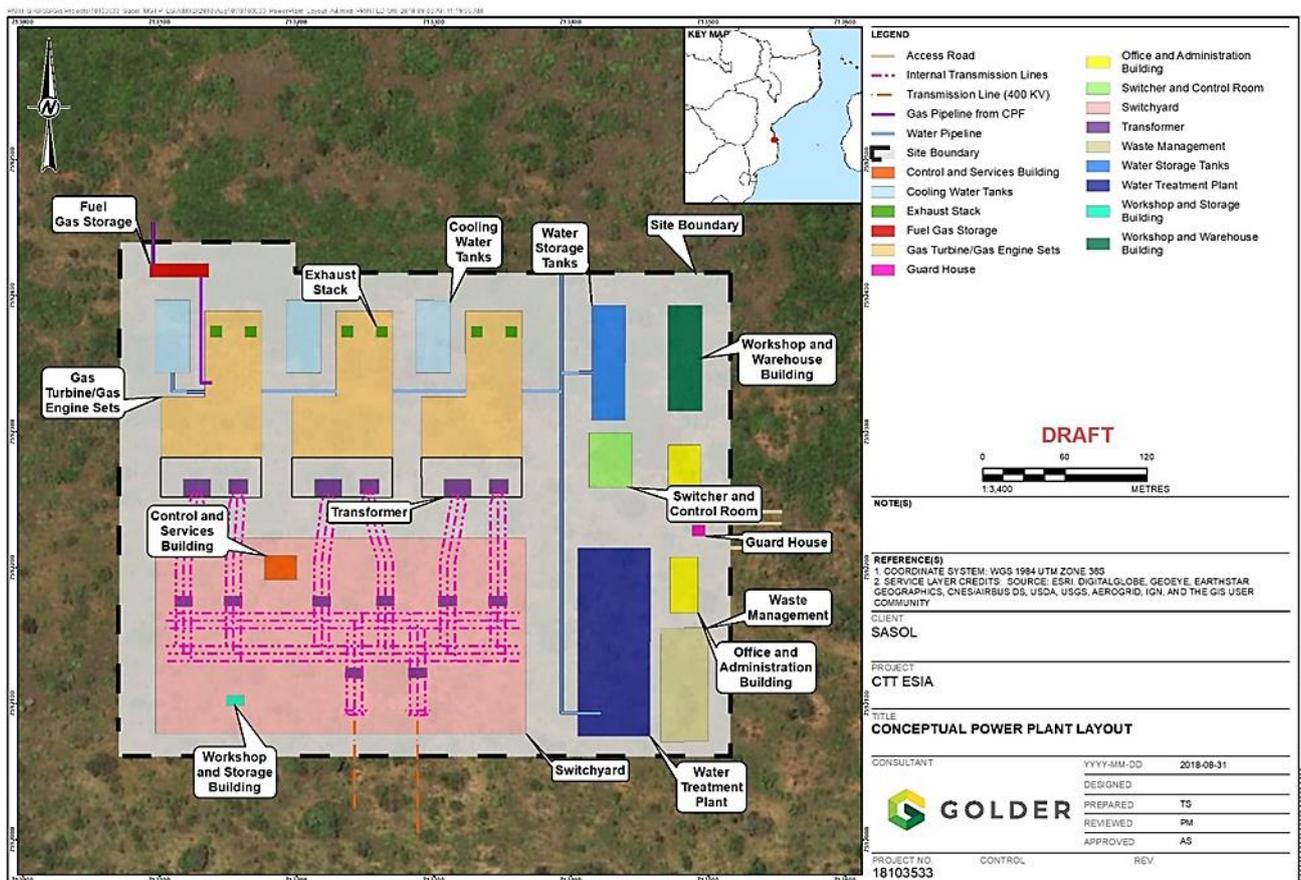
Figure 3: Conceptual layout of CTT plant site

At this early stage in the project a provisional layout of infrastructure footprints, including the proposed linear alignments is indicated in Figure 1. A conceptual layout of the CTT plant site is shown below in Figure 3.

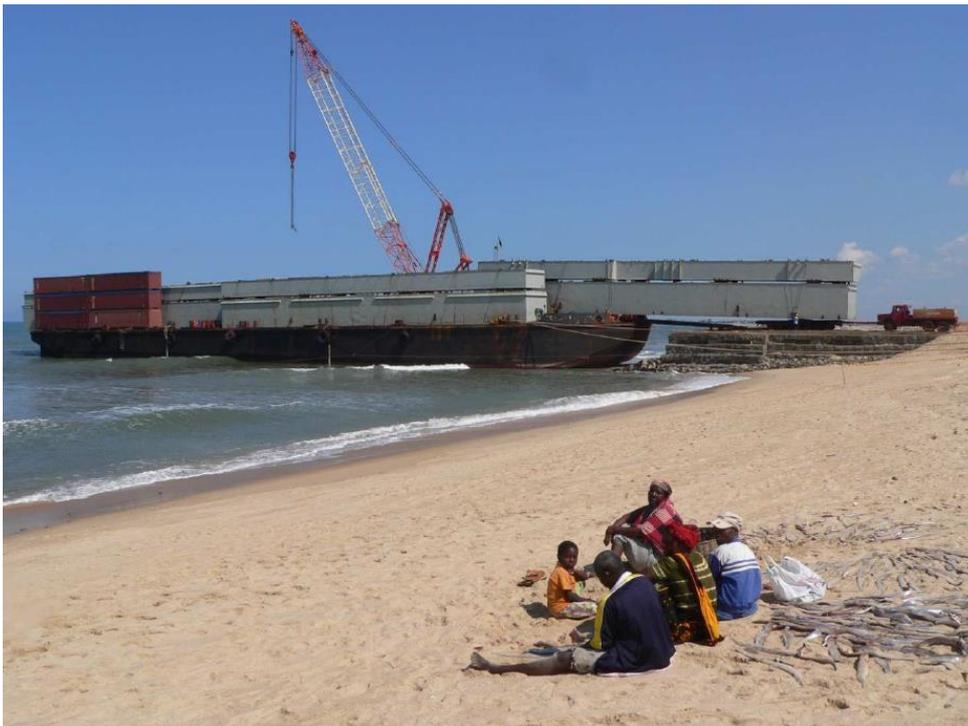
Figure 4: Typical beach landing site with barge offloading heavy equipment (source: Comarco)

The heavy equipment and pre-fabricated components of the power plant will be brought in by ship and transferred by barge and landed on the beach near Inhassoro. The equipment and components will be brought to site by special heavy vehicles capable of handling abnormally heavy and large dimension loads. Figure 4, Figure 5 and Figure 6 show examples of the activities involved with a temporary beach landing site, offloading and transporting of large heavy equipment by road to site.

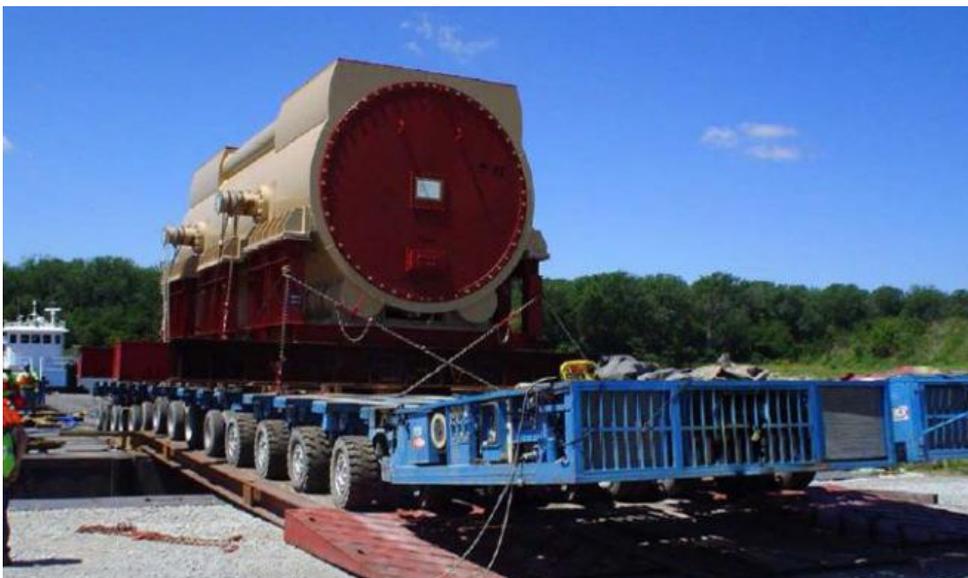
Figure 5: Example of large equipment being offloaded from a barge. Note the levels of the ramp, the barge and the jetty (source: SUBTECH)

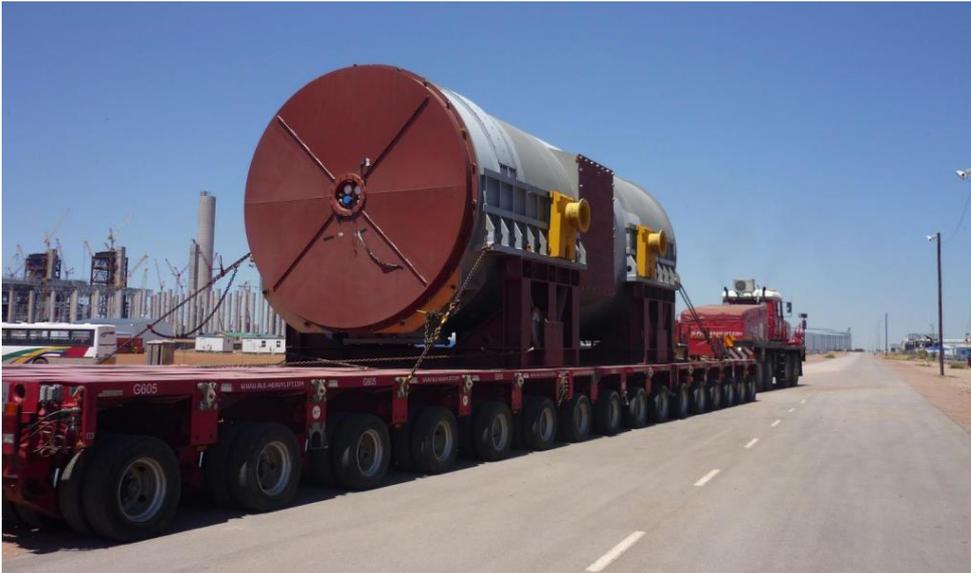
Figure 6: Heavy haulage truck with 16-axle hydraulic trailer transporting a 360 ton generator (source: ALE)

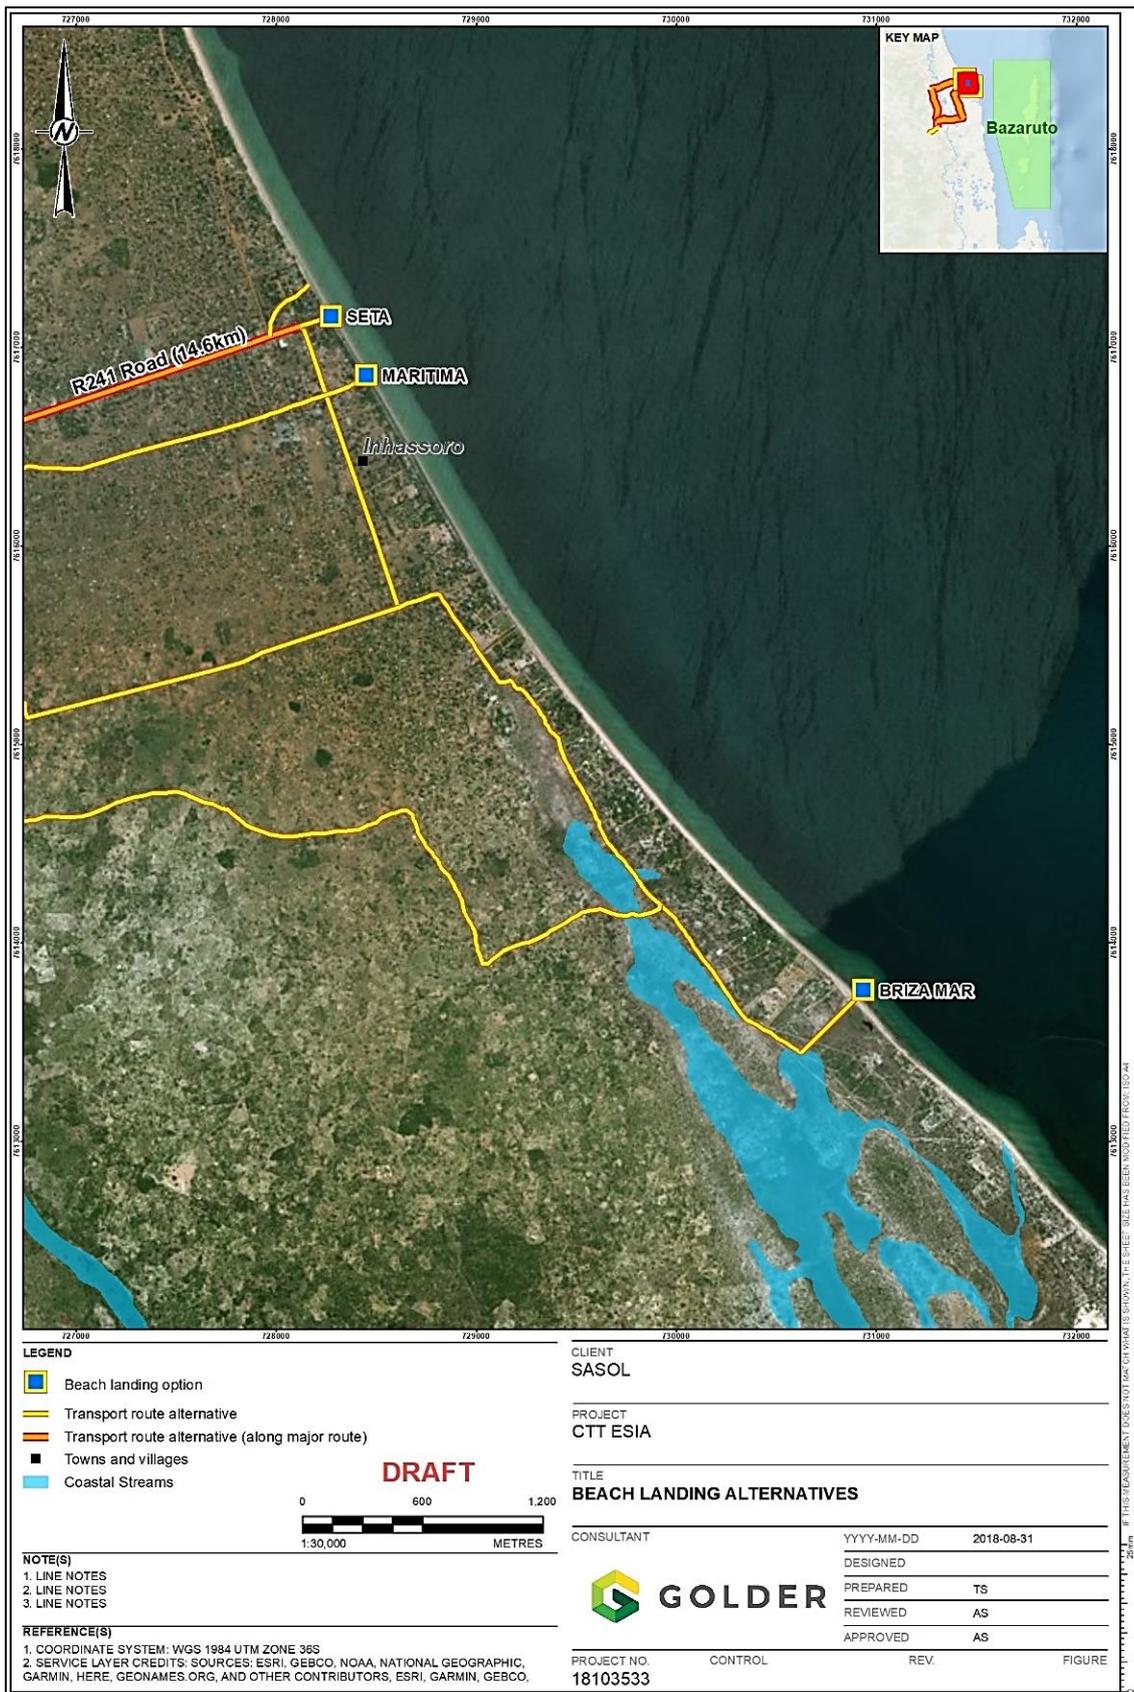
Figure 7: The three beach landing site options and route options at Inhassoro

Currently, the SETA beach landing site is the preferred beach landing site together with the road route option to be used in transporting equipment and materials along the R241 then the EN1 then via the existing CPF access road to the CTT site near the CPF. Figure 7 and Figure 8 indicate the beach landing site and route transportation option. The alternative beach landing sites of Maritima and Briza Mar are still being evaluated as potential options, as well as the southern transport route, which would also require road upgrades and a temporary bridge construction across the Govuro at the position of the existing pipe bridge. As part of the transportation route, the Govuro River bridge may need to be upgraded / strengthened to accommodate the abnormal vehicle loads. Alternatively, a temporary bypass bridge will be constructed adjacent to the existing bridge.

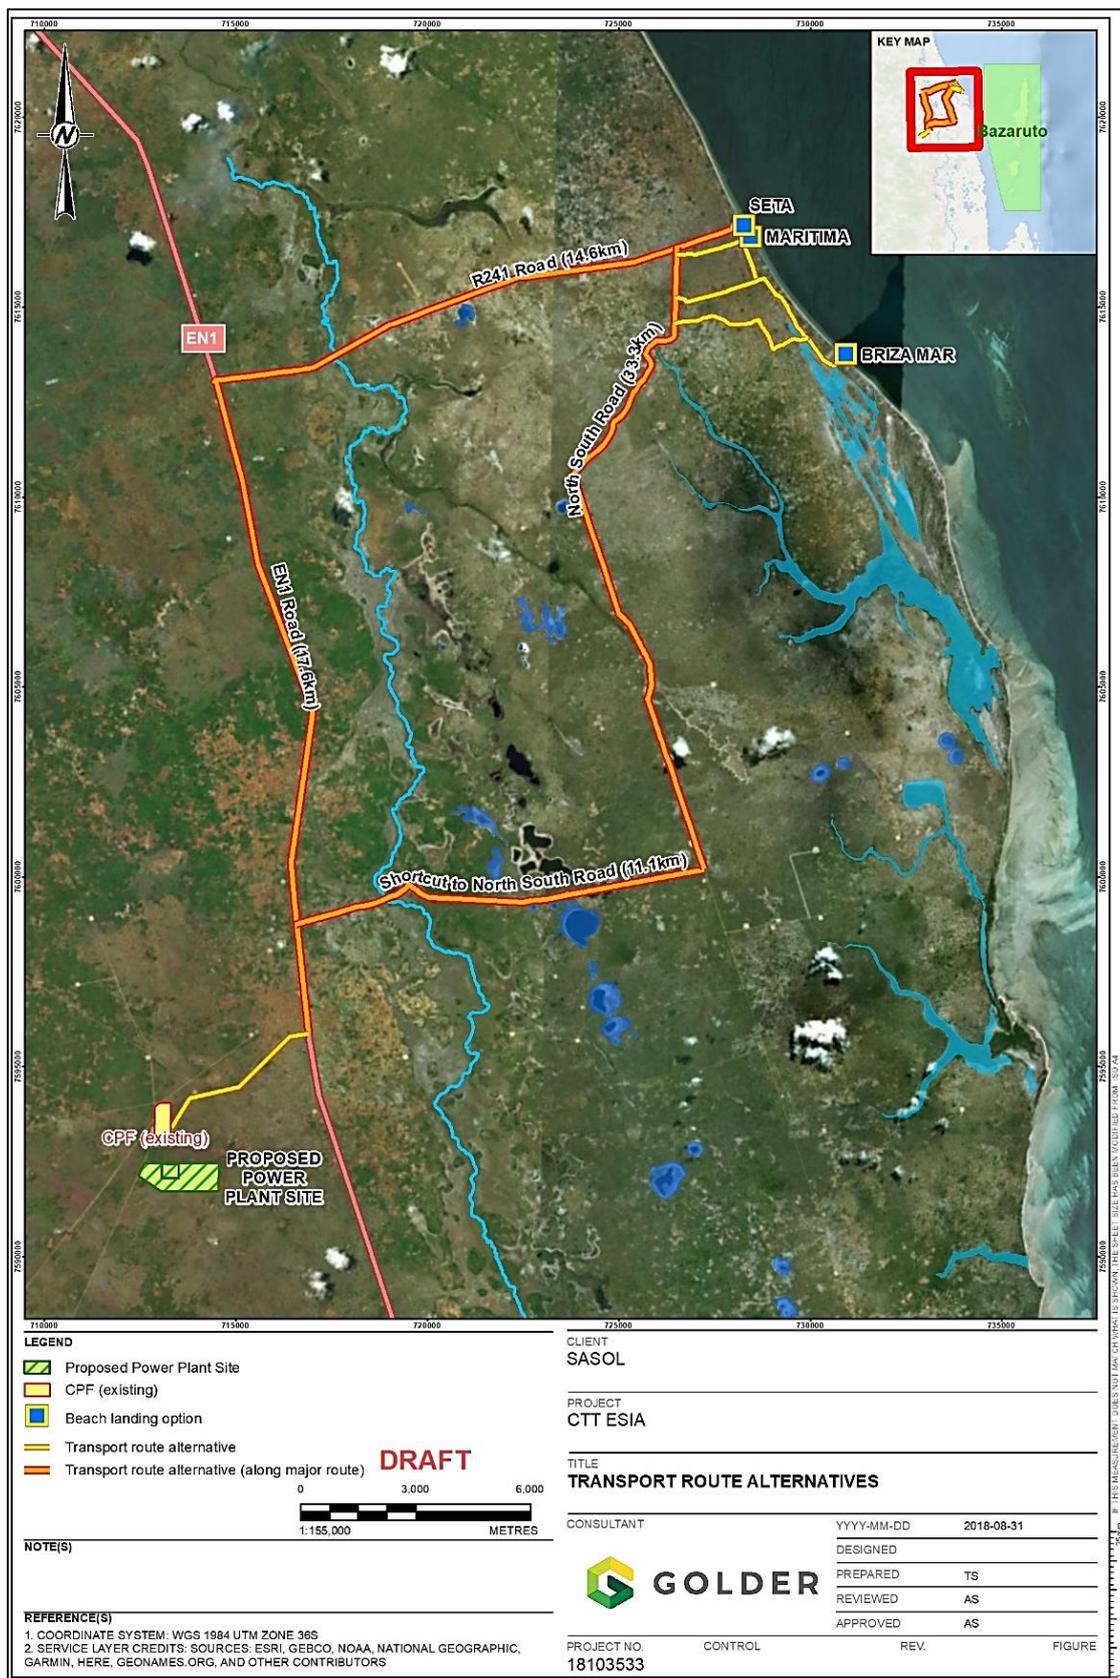
Figure 8: The two main transportation route alternatives from the beach landing sites to the CTT site

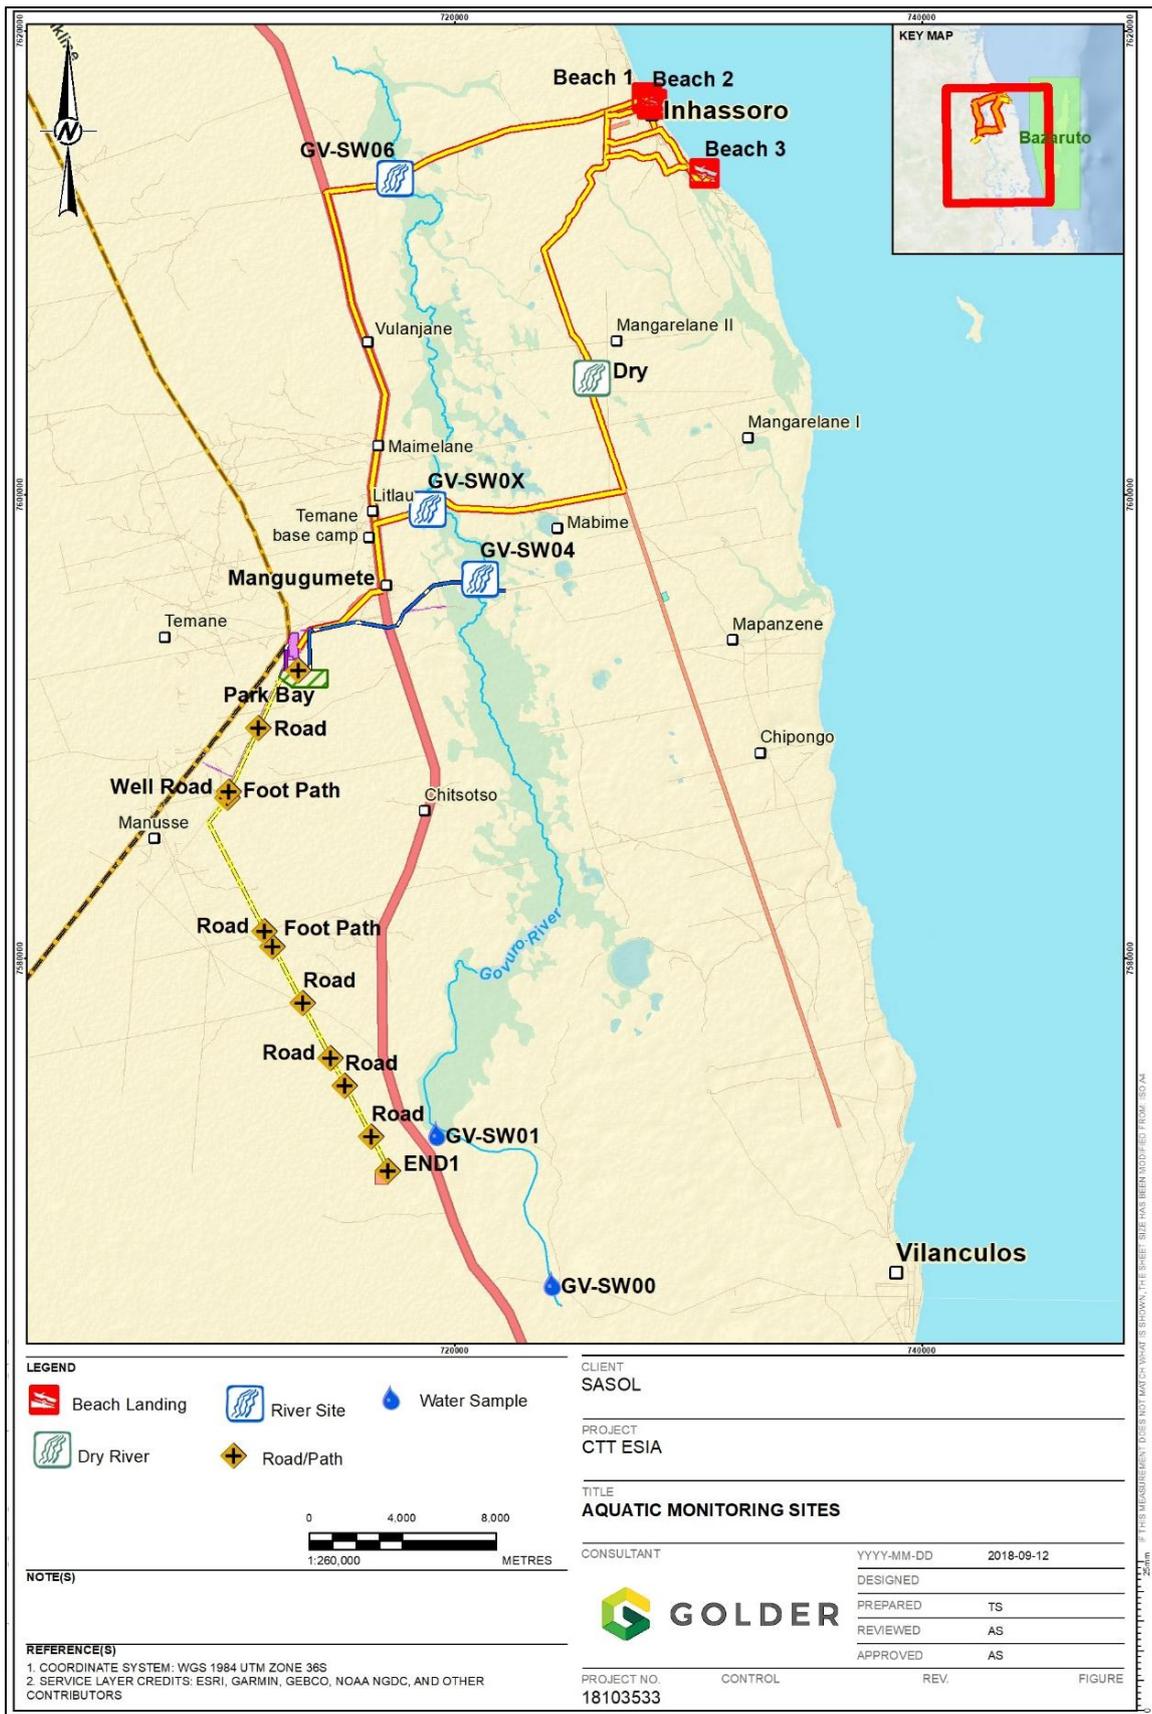
Figure 9: Aquatic sampling sites, with water sampling points and beach landing sites represented for context

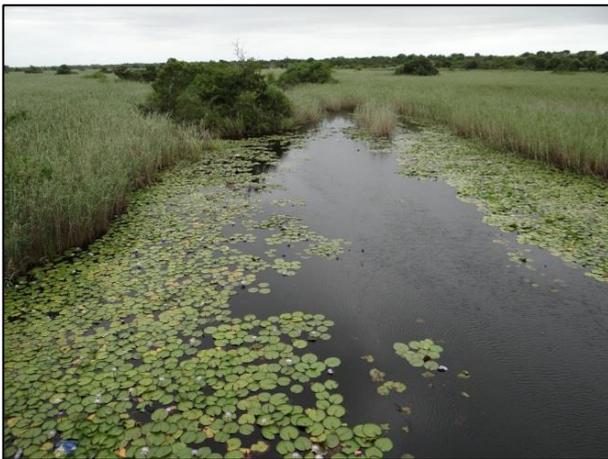
Figure 14: Govuro River Channel (GV-SW00)

The centre of the channel is typically open water, with a sand and fine gravel substrate (Figure 14 and Figure 16). Although a few rocks were observed, no rapid or riffle habitats were noted or sampled. These attributes resulted in two main hydraulic units being present, Slow Shallow (SS) and Slow Deep (SD). Backwaters along the edges of the floodplain are seasonally-inundated and with emergent vegetation create favourable habitat for smaller fish, fish fry, amphibians and other species. The riparian habitats consist mostly of inundated floodplain habitats. Riparian trees are scarce as the riverine zone rapidly merges into the terrestrial woodland system.

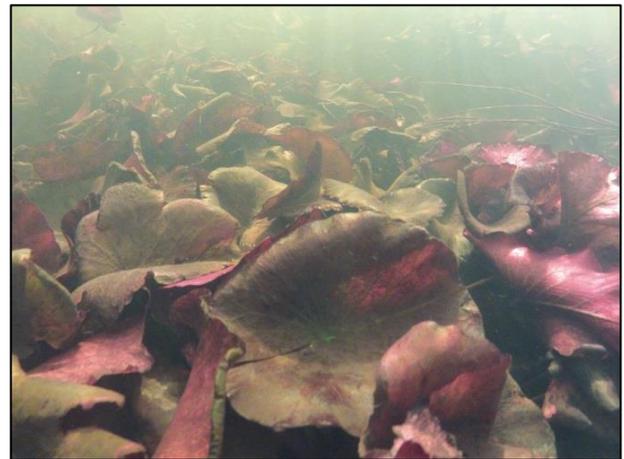
Figure 15: Submerged *Nymphaea sp.* (Water Lily)

The Govuro River system consists of the flowing river (aquatic) and the associated floodplain (riparian). The Govuro River channel is dominated by emergent vegetation comprising *Phragmites australis* (Common Reed) and *Nymphaea sp.* (Water Lily) (Figure 14). Figure 15 shows how the margins of the channel are dominated by detritus and submerged lilies. Organic debris not only provides a variety of structure, but also contributes to the transfer of nutrients within the system, being an allochthonous³ source of food.

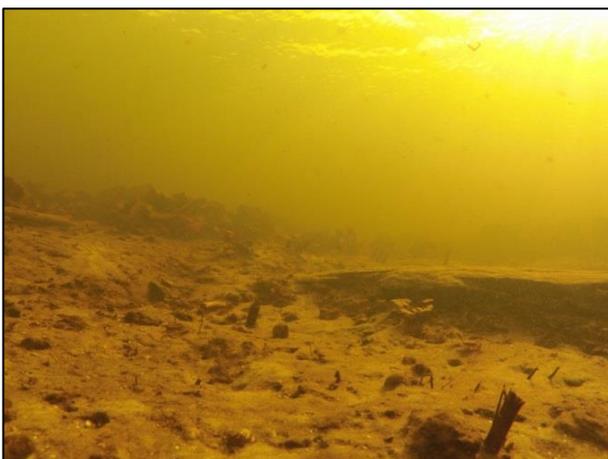
Figure 16: Sandy substrate in the centre of the Govuro River channel

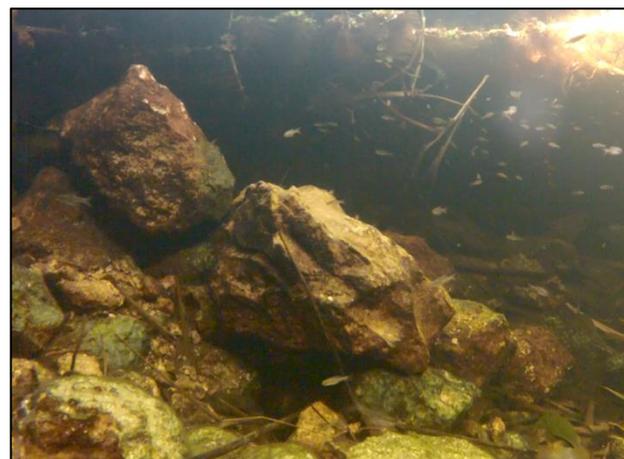
Figure 17: Rock habitat at site GV-SW06

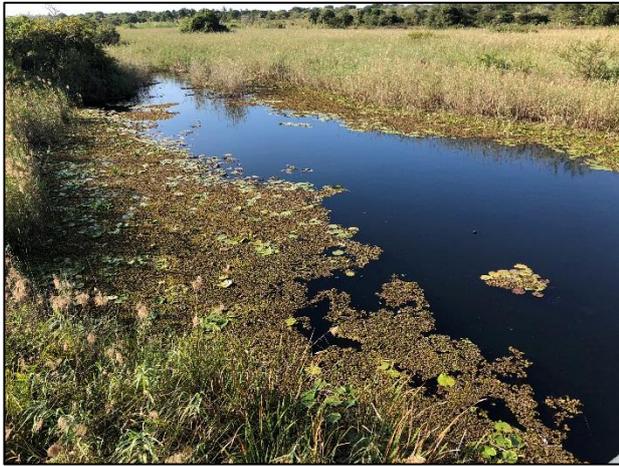
Figure 18: Kariba Weed (*Salvinia molesta*)

During the June 2018 survey, large amounts of Kariba Weed (*Salvinia molesta*) were observed at site GV-SW00. This was the first time that large quantities of this invasive species were observed at this site (Figure 18).

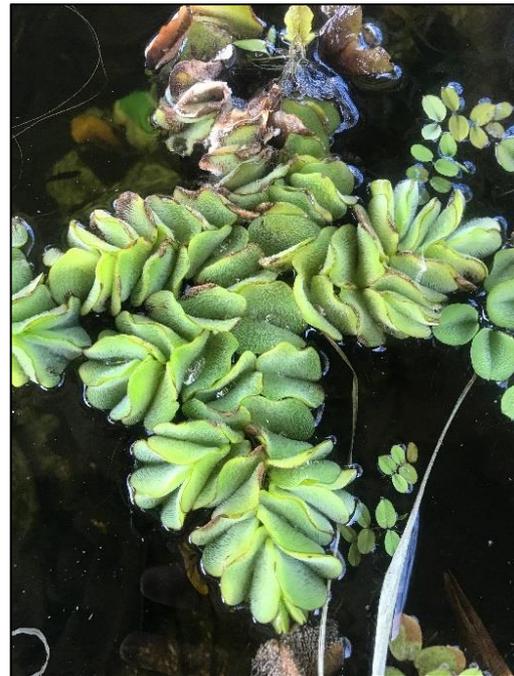
Figure 19: Photographs of sites to illustrate homogeneity (2015 and 2018)

No stones-in-current were present and the substrate, flow, depth and vegetation were considered homogenous across all sites (Figure 19).

The IHAS is often used in rapid biological monitoring assessments to numerically reflect the quantity, quality and diversity of biotopes available for macroinvertebrates to inhabit at a sampling site (Dallas, 2000; McMillan, 1998; Ollis *et al.*, 2006). Due to the homogeneity of sandy substrate, accompanied by the lack of stones-in-current, vegetation and uniform flow velocities, the IHAS index did not prove to be applicable for the Govuro River as the scores ranked all of the sites similarly, and classified all as ‘poor’, which is considered a misrepresentation of the current status of the Govuro River within the study area, which remains in a largely natural condition. Therefore, a more general approach to physical conditions was adopted.

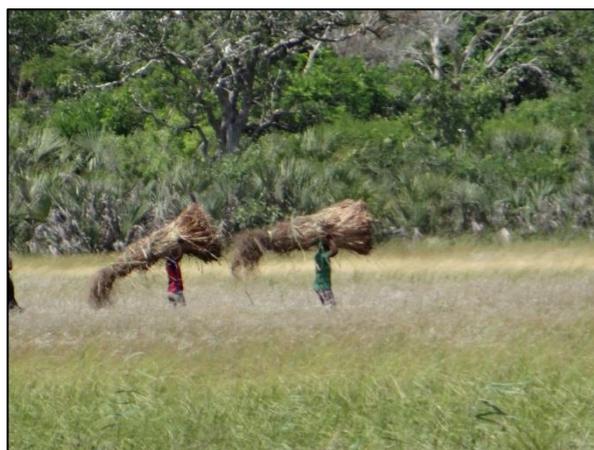
Figure 20: Harvesting of grasses from the Govuro River

The riparian and aquatic habitats along the Govuro River are largely unmodified (falling within a habitat integrity class of Category A (natural) or B (near-natural)). Human use of the area for harvesting of reeds (*Phragmites sp.*) and saw grass (*Cladium mariscus*) has had limited impact and is currently considered to be at sustainable levels.

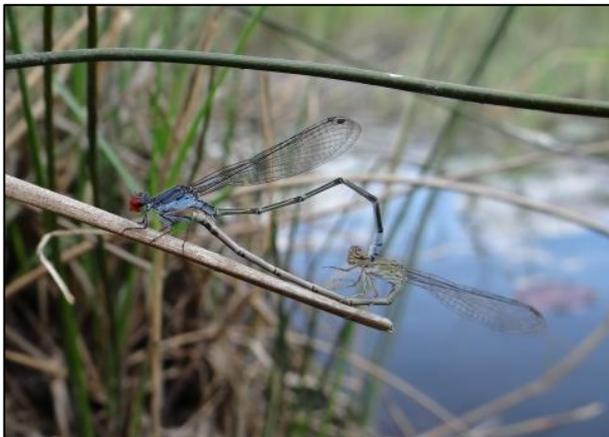
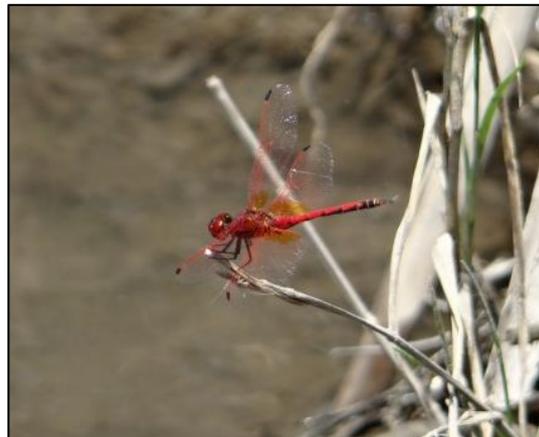
Figure 21: Selection of Odonata species observed

Figure 21 shows a selection of some of the Odonata observed onsite during February 2015.

In addition, dragonflies and the damselflies (Odonata) can be used to monitor any changes within the system. Odonata are an order of carnivorous insects, that are typically associated with both aquatic and terrestrial ecosystems with the larval stage centred around the aquatic ecosystems. Odonata are well studied and are used globally as an indicator species (Clark and Samways 1996; Foote & Hornung 2005).

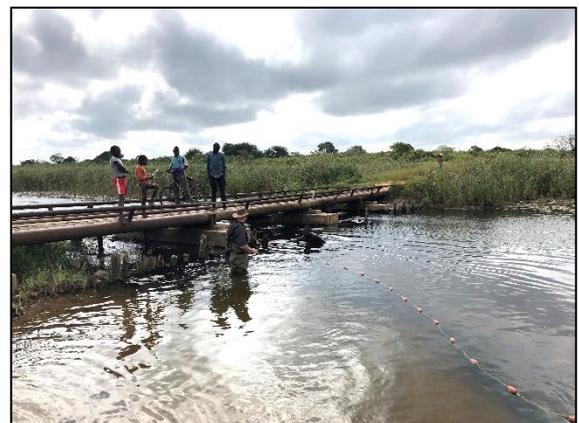
Figure 26: Seine netting at site GV-SW0X
