# Site Visits Report (September 2021)

E&S SITE VISITS OF QUARRIES, MOBILIZATION CAMPS,  
CONCRETE & PRECAST PRODUCTION AREAS

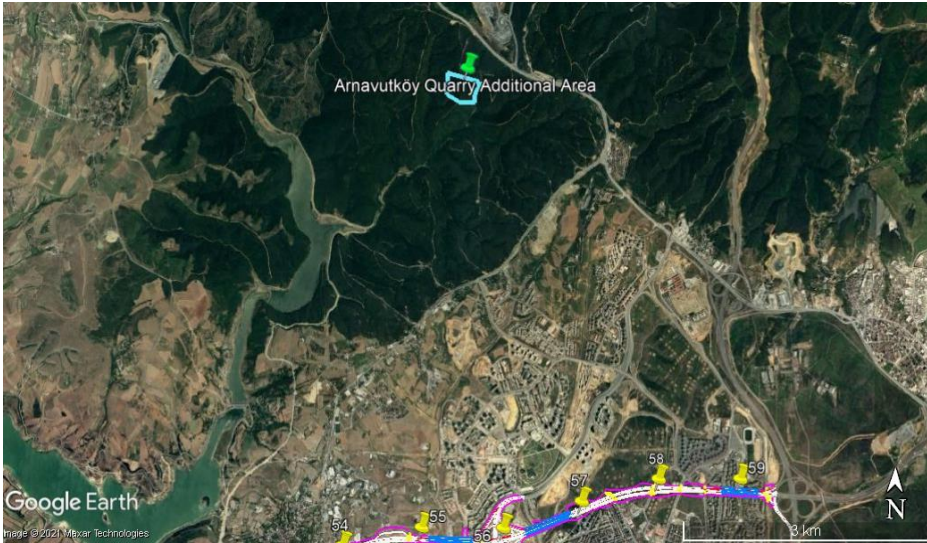
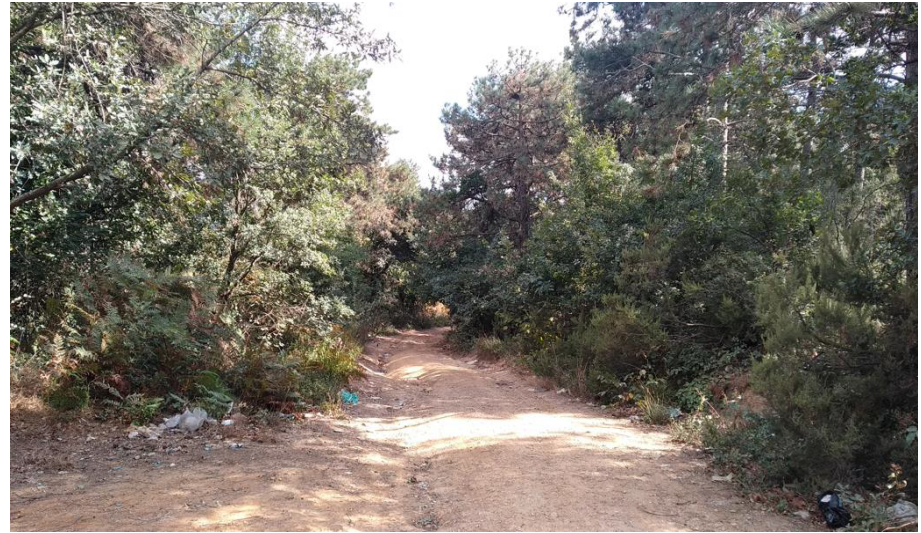
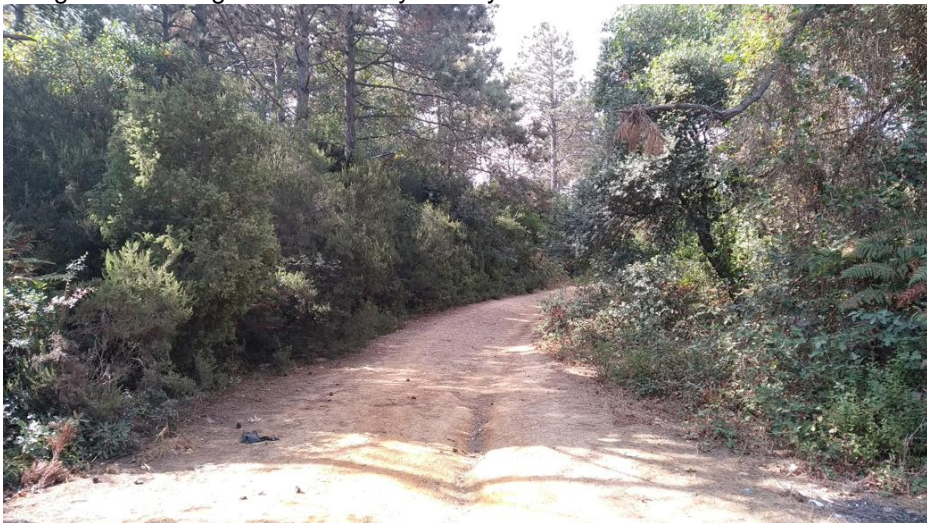
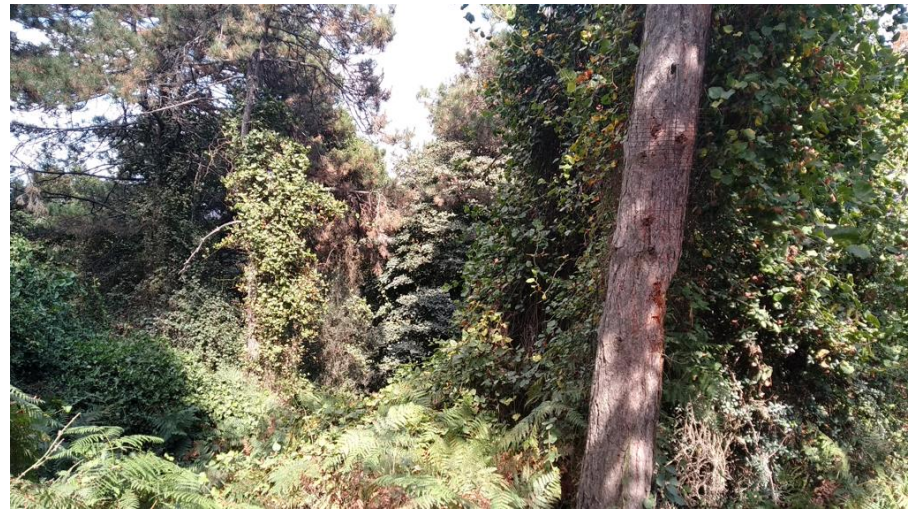
**Environmental and Social Issues at Site Visit** The proposed site is currently located in a forest. The construction have not started yet. There is only a narrow pathway to the area. The forest will be the most affected area during the construction and operation phases.

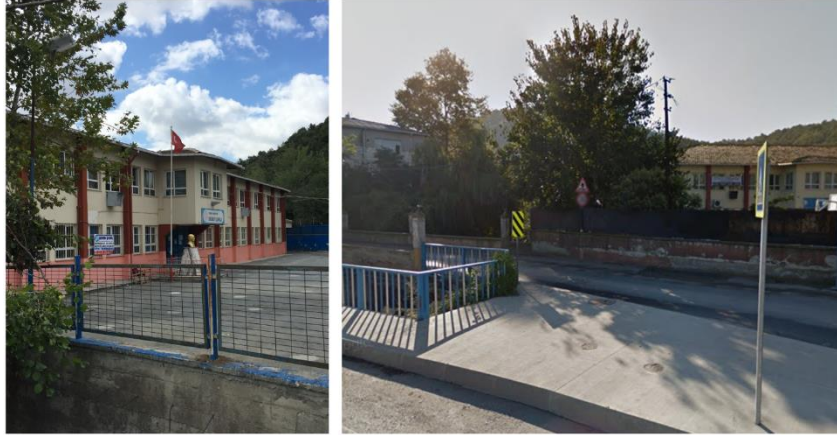
**Figure 1-4 Photos of Boğazköy Primary School**

The Boğazköy Elementary School is located on Milli Egemenlik Street, between the mosque and Boğazköy Cemetery. It is about 200-300 meters from the project zone. A small playground is in front of the school. There are playgrounds in the courtyard as well.

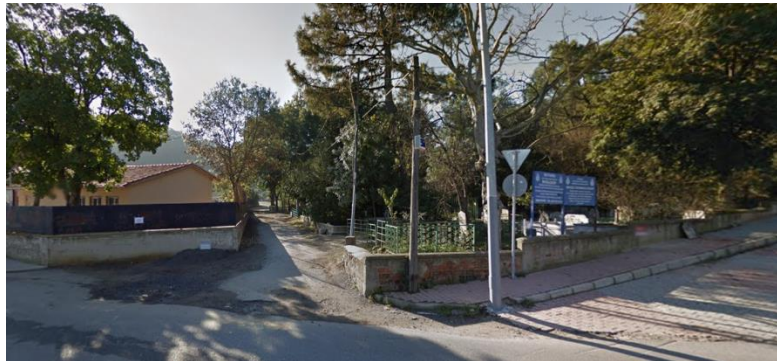
**Figure 1-5 Photos of Boğazköy Cemetery**

Boğazköy Cemetery lies at the intersection of Milli Egemenlik and Ziyali streets and above the school. The aerial distance to the project site is around 200 to 300 metres.

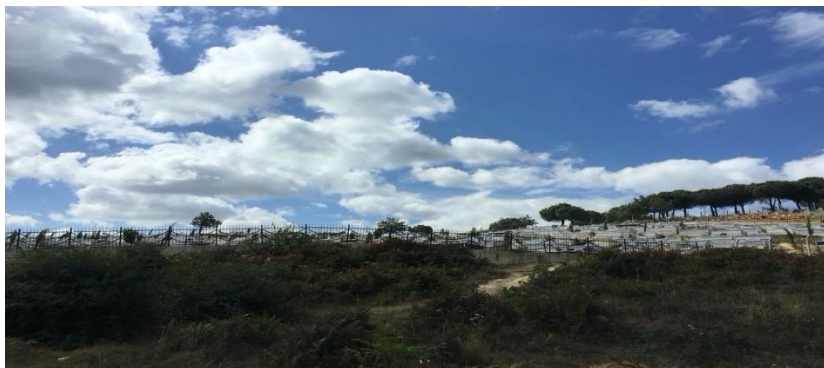
**Figure 1-6 Photos of Boğazköy Upstream Cemetery**

Boğazköy Upstream Cemetery is approximately 2 km away from the project area as arial distance.

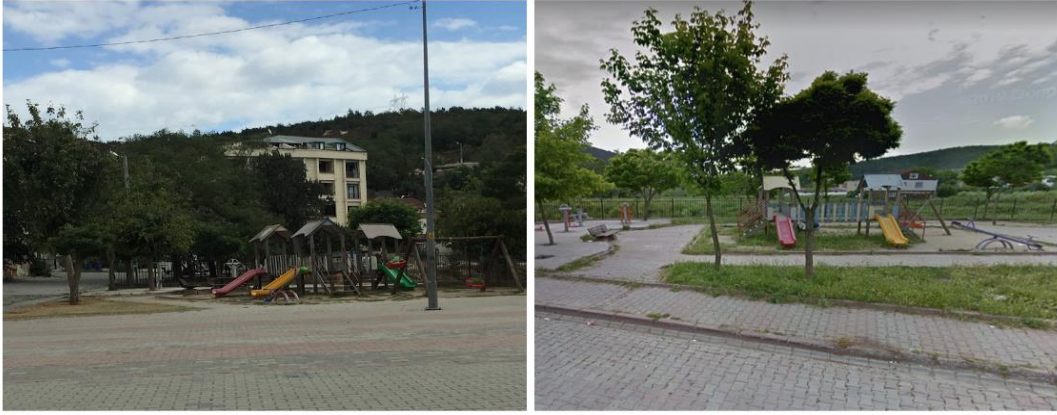
**Figure 1-9 Park on Devlet Street**

Bogazköy has three parks. There is one on Devlet Street. The other park stands behind the school. There is also a football pitch in this park. The last park is on Milli Egemenlik Street, over the intersection adjacent to the school.

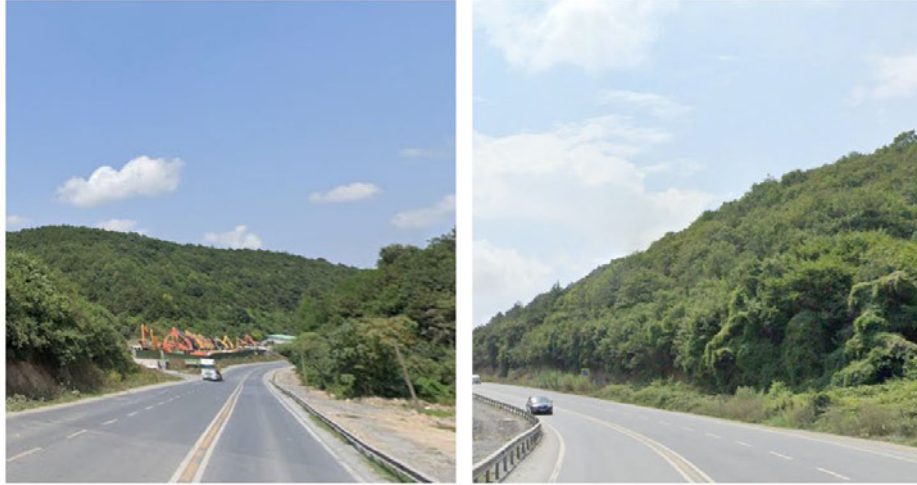
**Figure 1-12 The eastern part of the quarry**

The eastern part of the quarry is completely forested and there is no settlement, agriculture or commercial area.

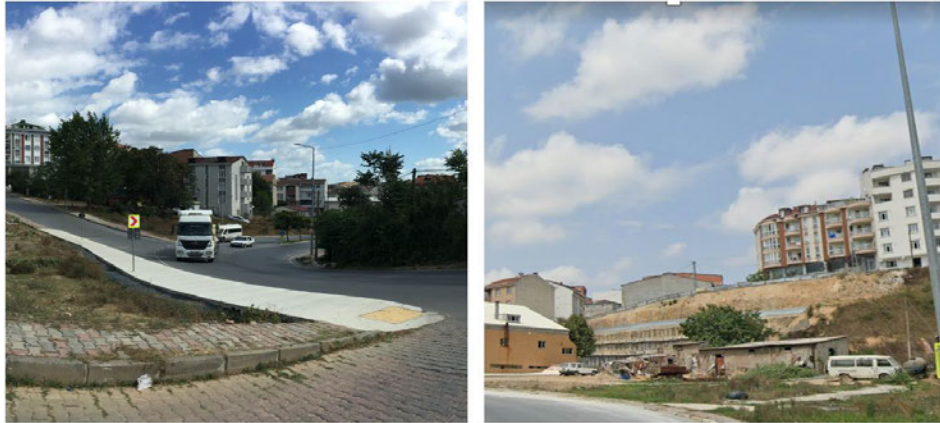
**Figure 1-13 Photos from western side of Arnavutköy Quarry**

There are industrialized commercial areas and settlements in the northwest of the area.

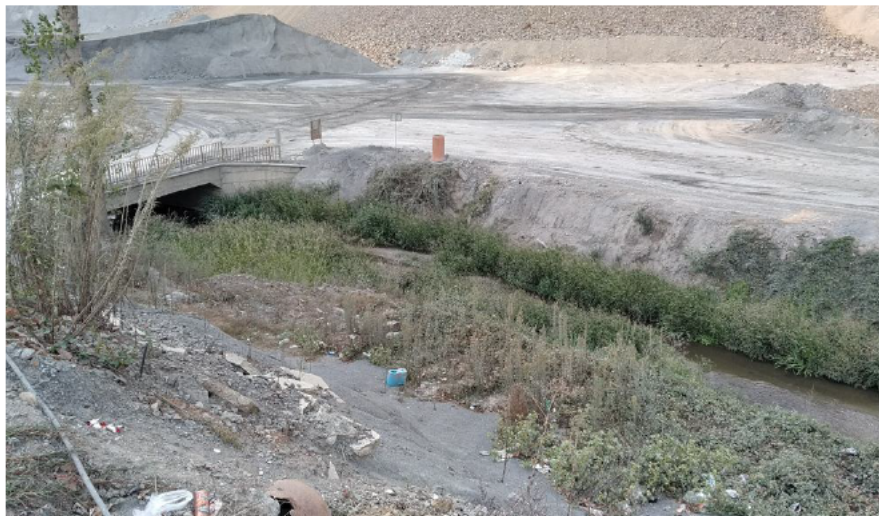
There is a creek within the site boundaries

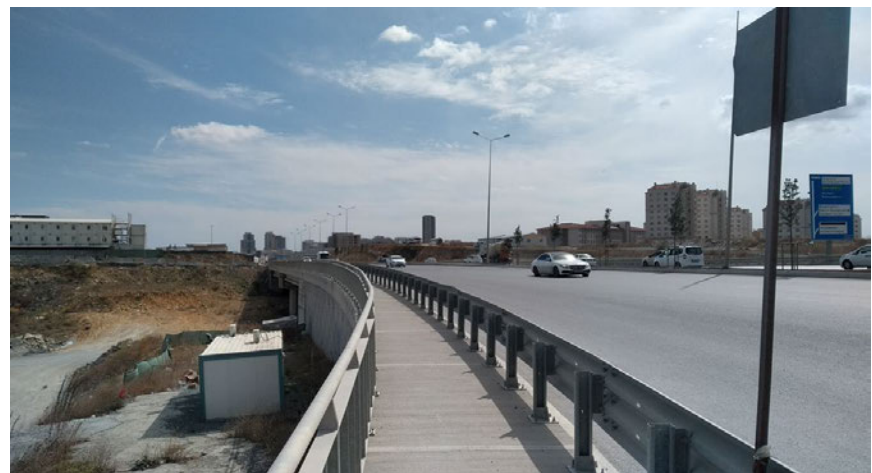
Residential area

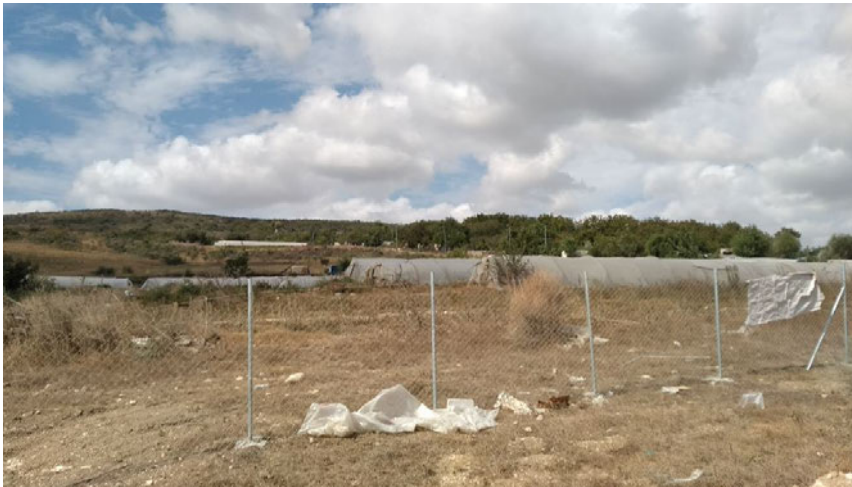
Greenhouses and seasonal houses on the west

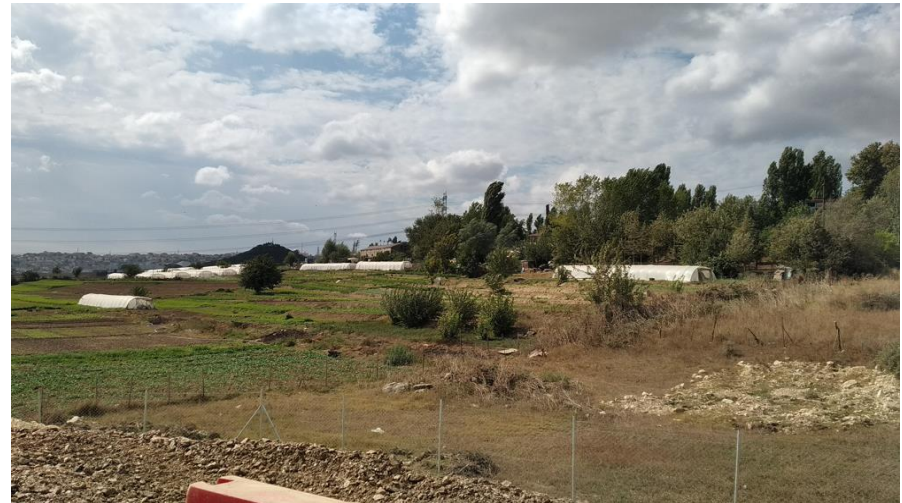
Greenhouses and seasonal houses on the west

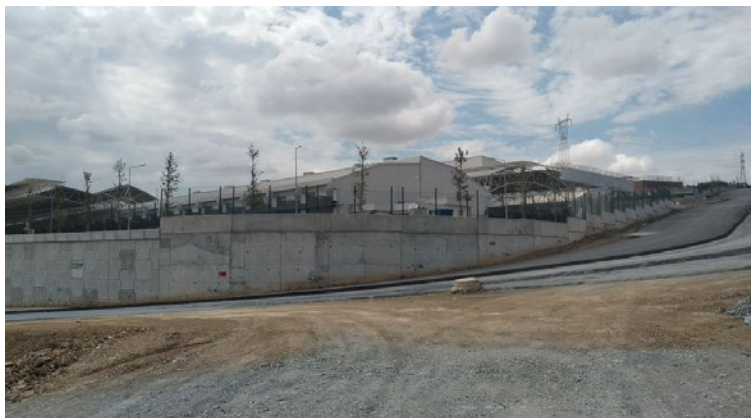
New Fruit-Vegetable Marketplace under construction and School on the South of the site

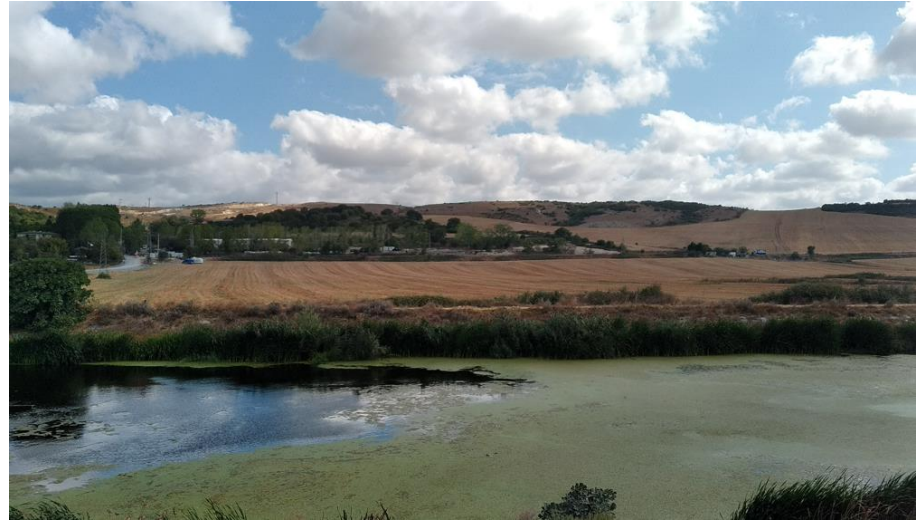
The Creek and farms on the east

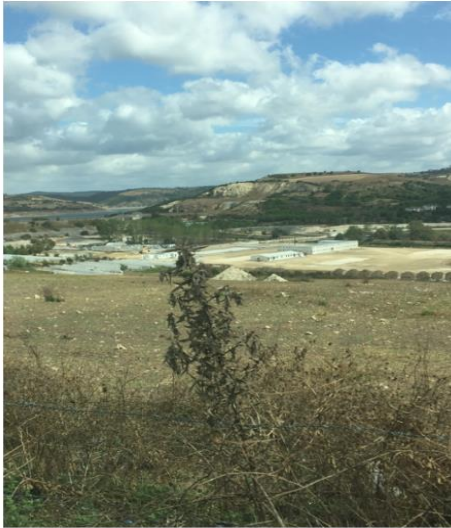
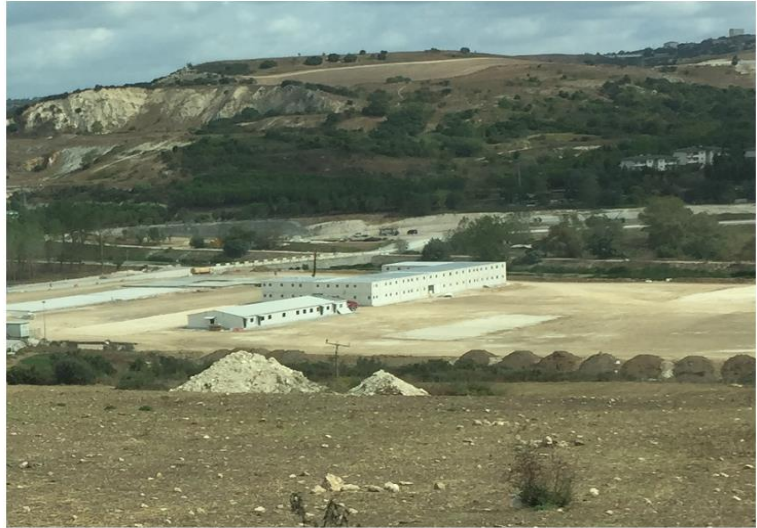
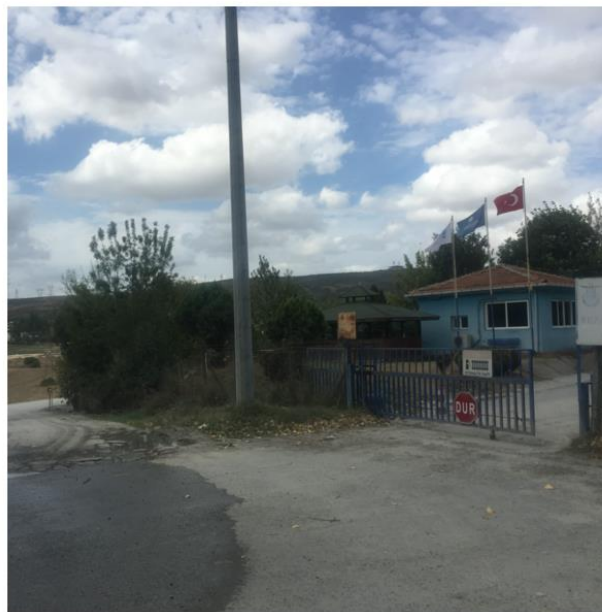
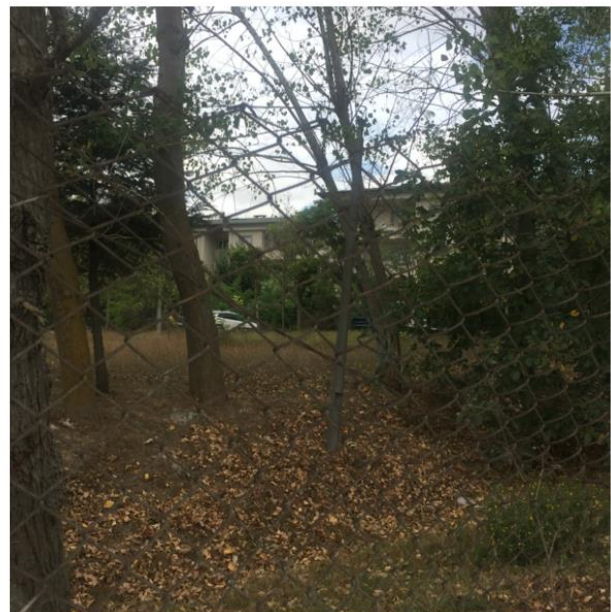
**Figure 7-1 Photos form İSKİ Lodgings**

Just above the boundaries of the field. It has four buildings, parks and social zones. The site is located under the base of the east tower of the bridge.

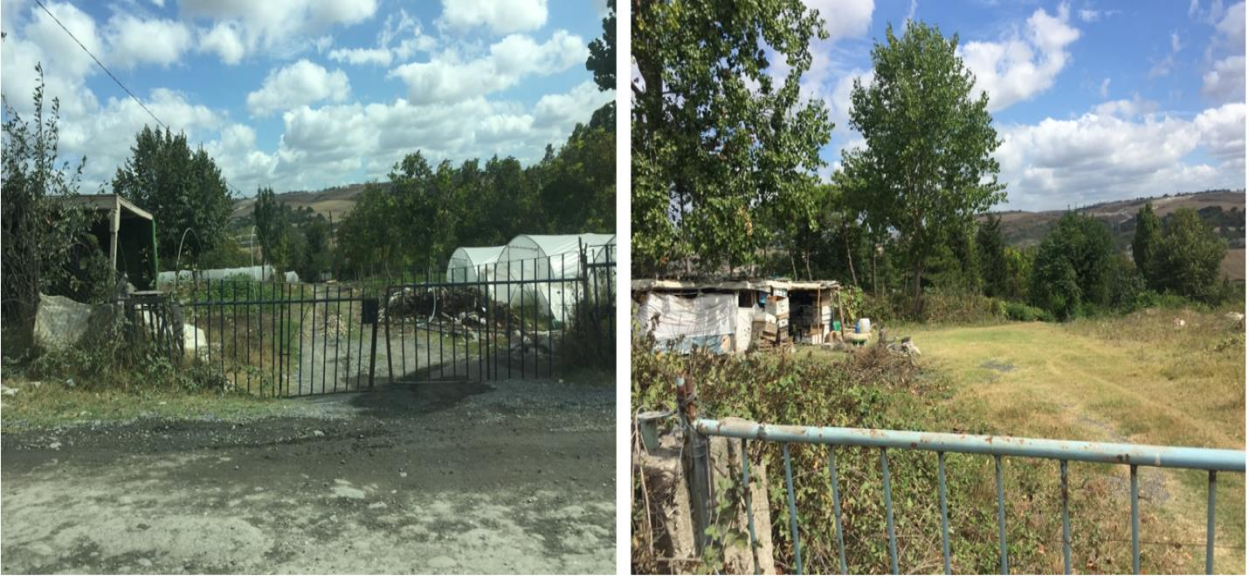
**Figure 7-7 Photos of beehives**

Cattle and small ruminants with irregular movements were observed in the project area. Additionally, a small number of cattle grazed by their owners were also seen. Additionally, a small number of cattle grazed by their owners were also seen. There are beehives in two nearby gardens on top of the greenhouses. The number of hives could not be picked up accurately. The hive gardens are located about 0.1-0.2 km from the field limit of the power plant/production site.

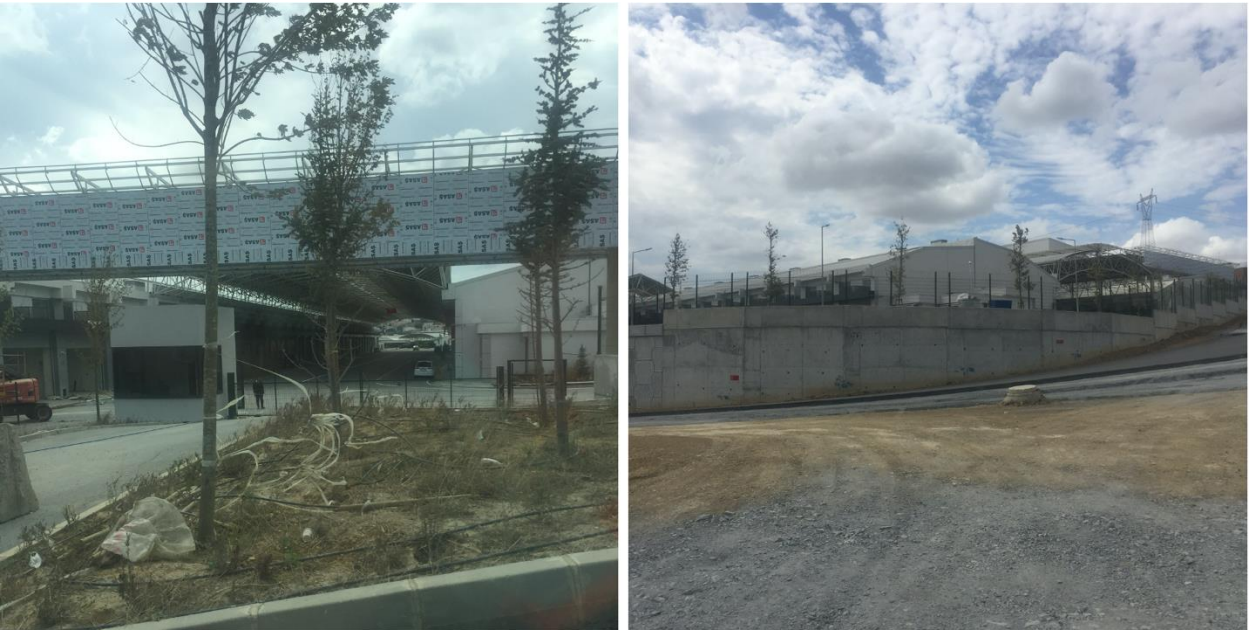
**Figure 7-8 Photos of Fresh Food Market**

It is approximately 0,5 km away from the project field.

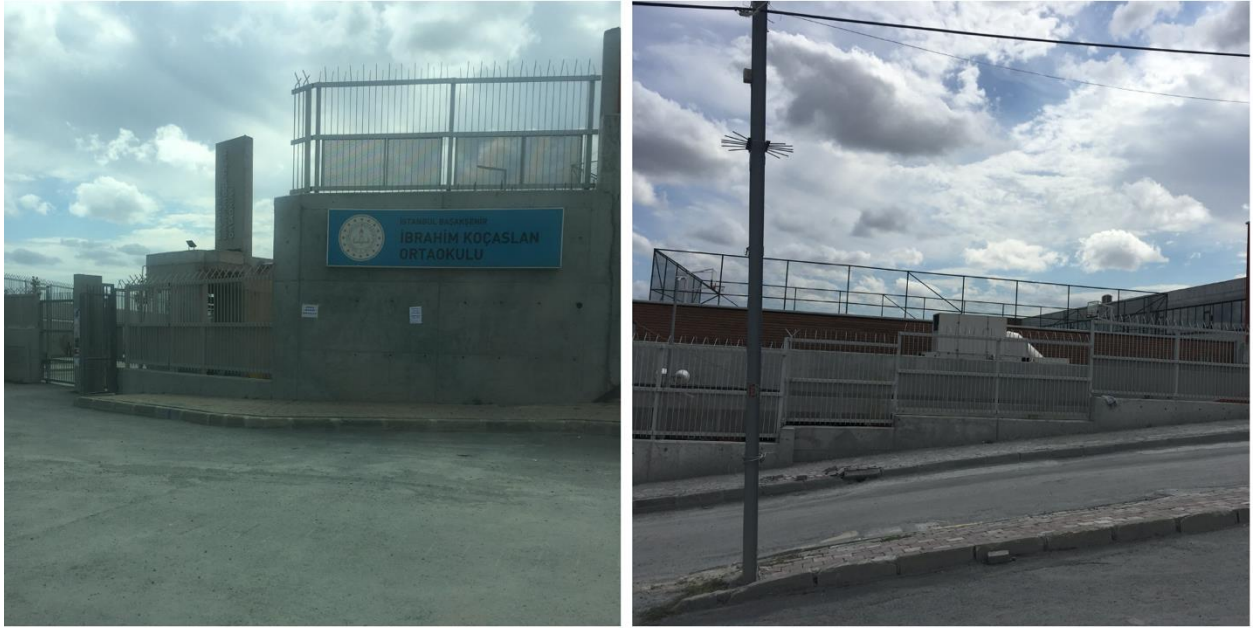
**Figure 7-9 Photos of İbrahim Koçaslan Secondary School**

It is approximately 0,5 km away from the project field.

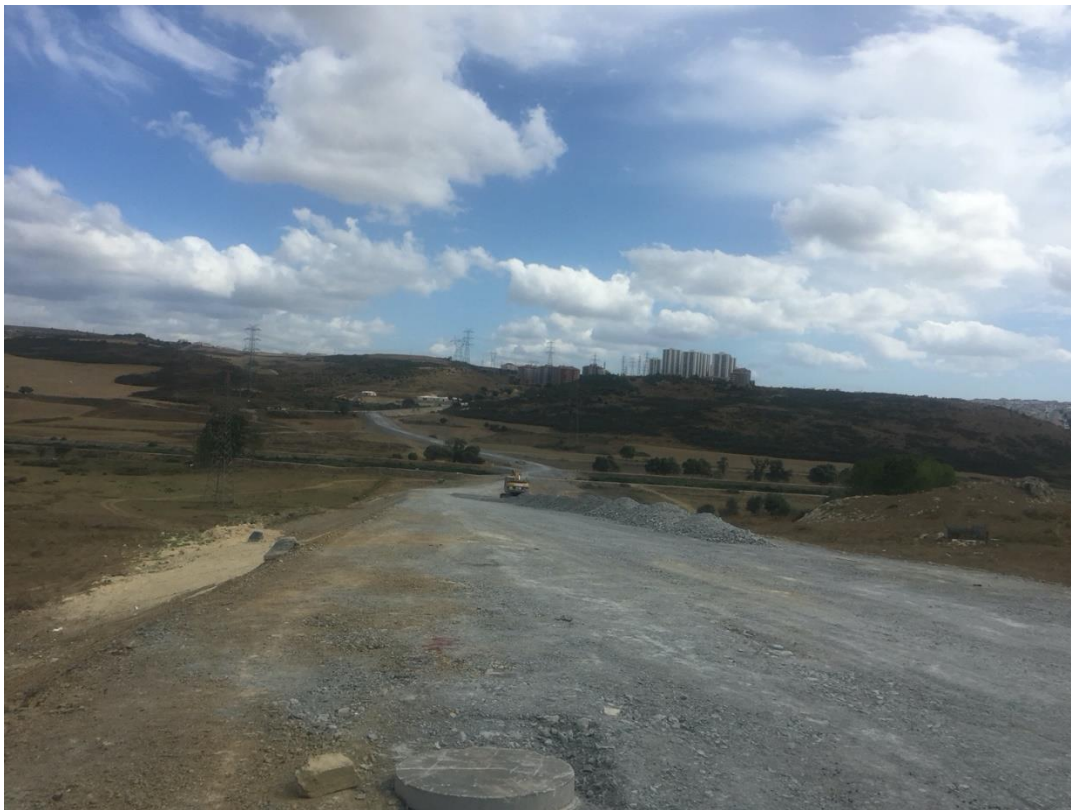
**Figure 7-10 Photos of Başakşehir Stray Animal Hospital and Kayabaşı Kiptaş Residence Site**

Başakşehir Stray Animal Hospital is approximately 0,5 km away from the project field while Kayabaşı Kiptaş Residence Site is approximately 1 km away.

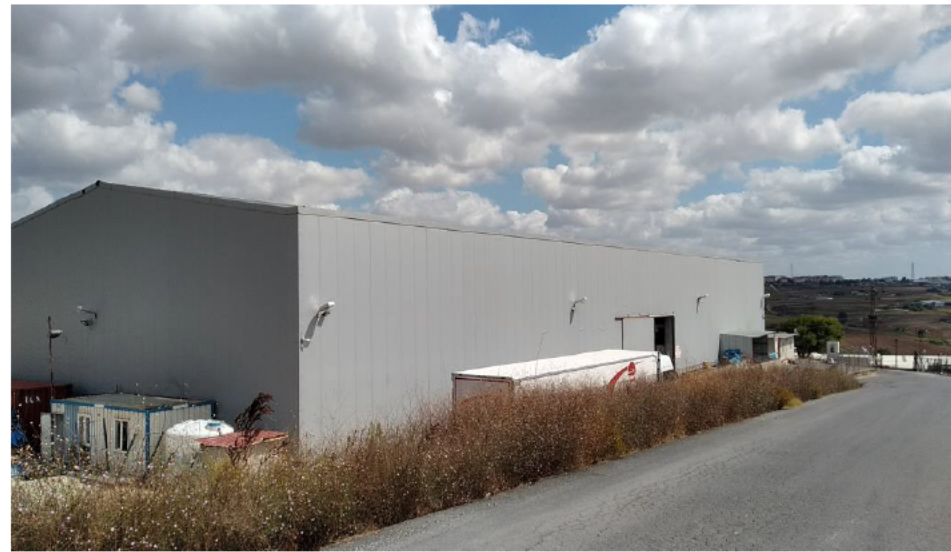
Logistics company building on the North

No settlement was found in the area where NAKKAŞ Concrete Plant is located. There are companies that have logistics centers in the region. As well, there is a prefabricated production center. Besides the logistics centers, the cultivated agricultural fields are located in the region.

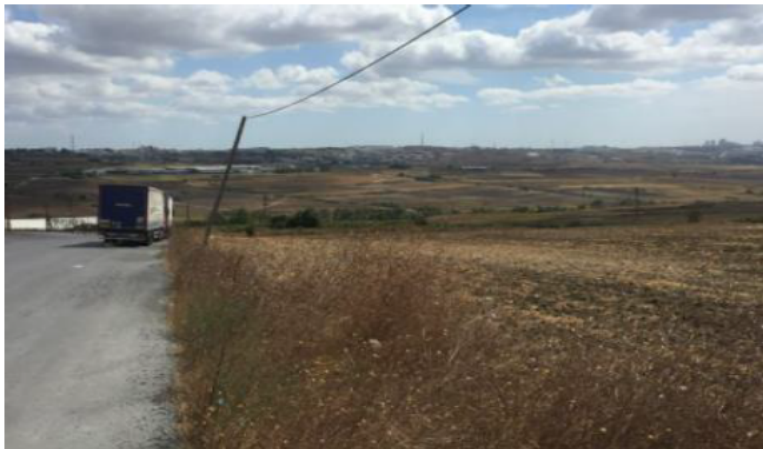
Farming areas on the West

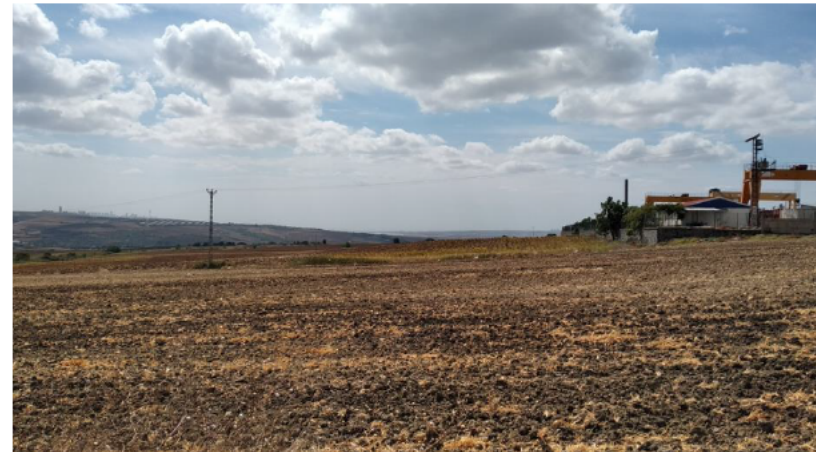
Planned construction area and prefabricated unit production area next to it.
